Rail Accident Report

Head-on collision between a passenger train and a freight train  
in Tempi, 28 February 2023

RL01-2025, 27 February 2025

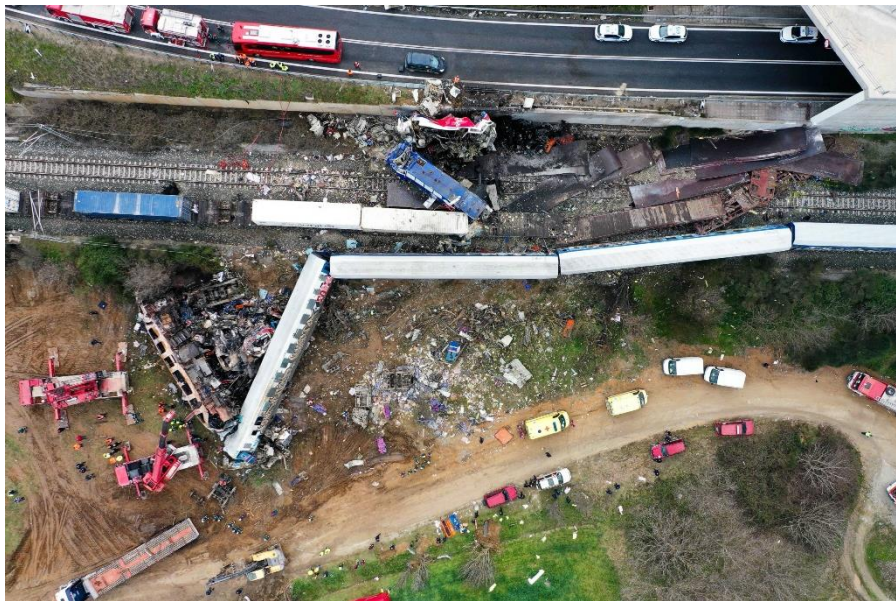
Figure 10. The end position of the 3 locomotives and some of the passengers coaches and freight wagons (<http://www.intime.gr/>).

- 130 The 1st phase mainly involved the first 4 vehicles of the two trains: 2 locomotives 120-022 (first) and 120-012 (second) of the freight train and the locomotive 120-023 with its first-class A1 coach. The initial impact is a head-on collision between passenger train locomotive 120-023 and the first freight train locomotive 120-022, that causes the latter, along with the second locomotive 120-012 to be catapulted towards their left over the upward line track and smashed against the motorway wall, with the second locomotive making a U-turn and its rear end sliding over the steel plates carried on the 3rd platform of the freight train to come to a standstill with its front side against the first locomotive and its rear end resting against the first shipping container carried on top of the 4<sup>th</sup> platform of the freight train (Figure 10, Figure 11, Figure 12).

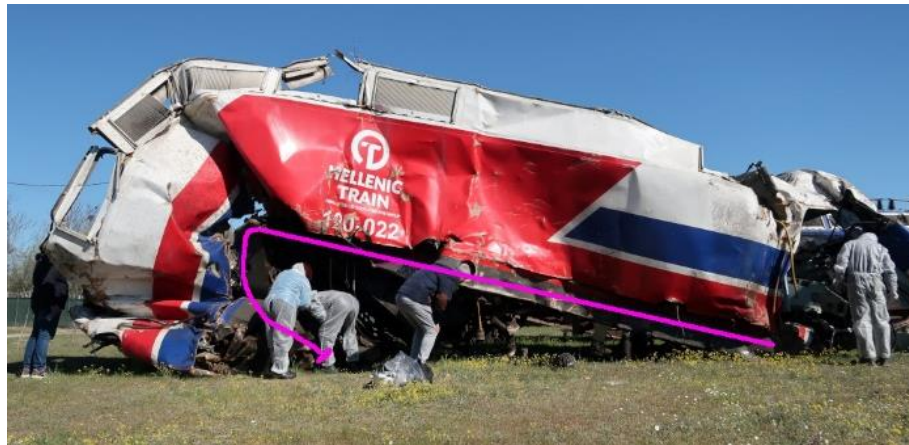
Figure 14. The first locomotive of the freight train (120-022) showing extreme damage from the very heavy head-on collision with the locomotive (120-023) of the passenger train.

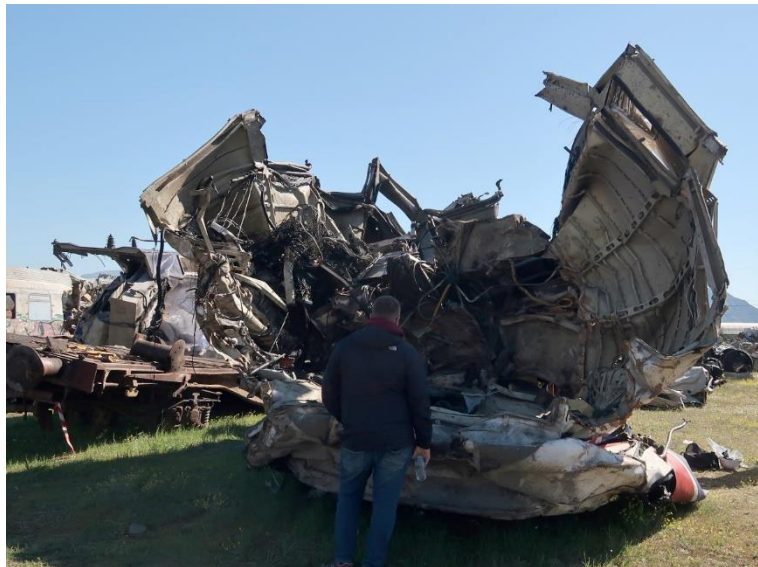
Figure 16. Front view of the locomotive 120-022, roof missing.

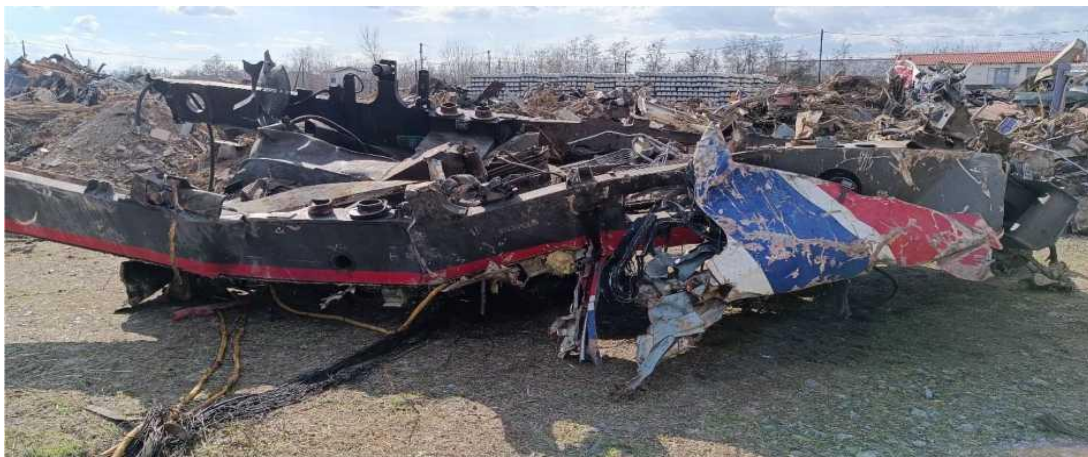
- 132 The passenger train locomotive 120-023 follows a slightly leftward path in its driving direction towards the lower verge, where it hits the ground, followed by the first-class passenger car. Due to the very heavy initial impact, this 120-023 locomotive has been completely destroyed (Figure 17), and its parts were found at an angle of approximately 20 degrees to the left and at a distance of 30 to 45 meters. The A1 coach of the passenger train was completely broken up due to the extreme mechanical loads of the impact and its heavier parts followed a path close to the path of the locomotive parts, at an approximate angle of 25 to 30 degrees to the left. Its lighter parts (seats, internal panels and fittings, luggage, and all casualties) were scattered in a wider area before the end position of the vehicle (see global Figure 12).

Figure 17. Part (chassis) of the completely destroyed locomotive 120-023 of the passenger train IC-62.

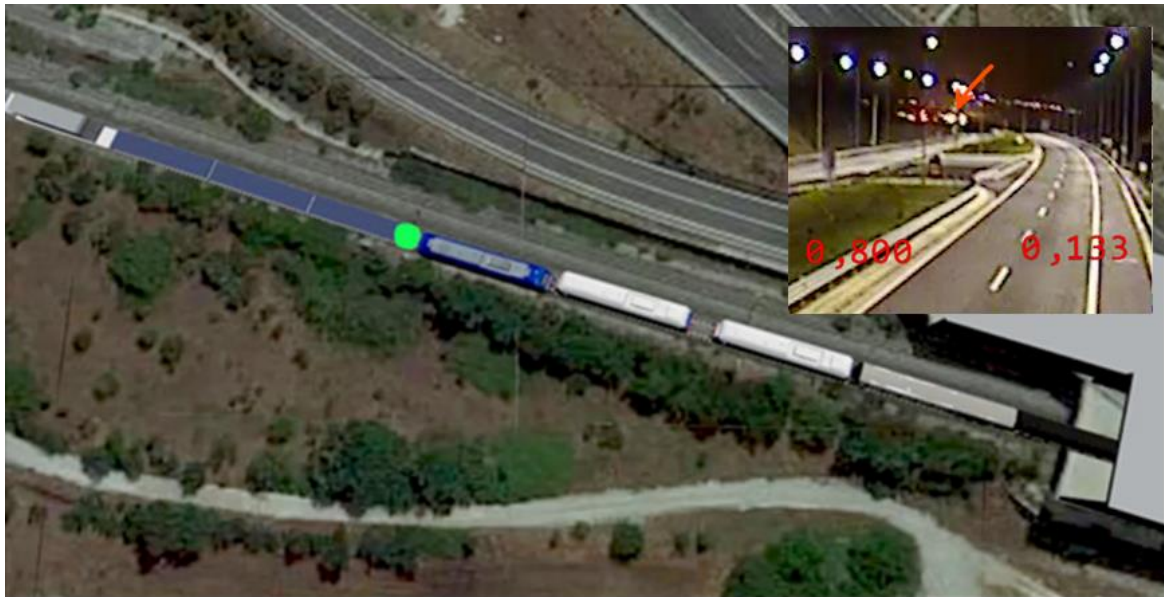
- 134 The second collision is another heavy head-on collision that takes place between the Restaurant Car (i.e. the 3<sup>rd</sup> vehicle) of train IC-62 and an area between the rear end of the locomotive 120-012 and the first of the wagons carrying steel plates (Figure 18). The effort to locate and examine all the remains of the corresponding vehicles of the freight train, shows that it is not possible to locate and identify all these parts.

Figure 18. Estimated area for second collision for the freight train (simulated image behind still of video footage).

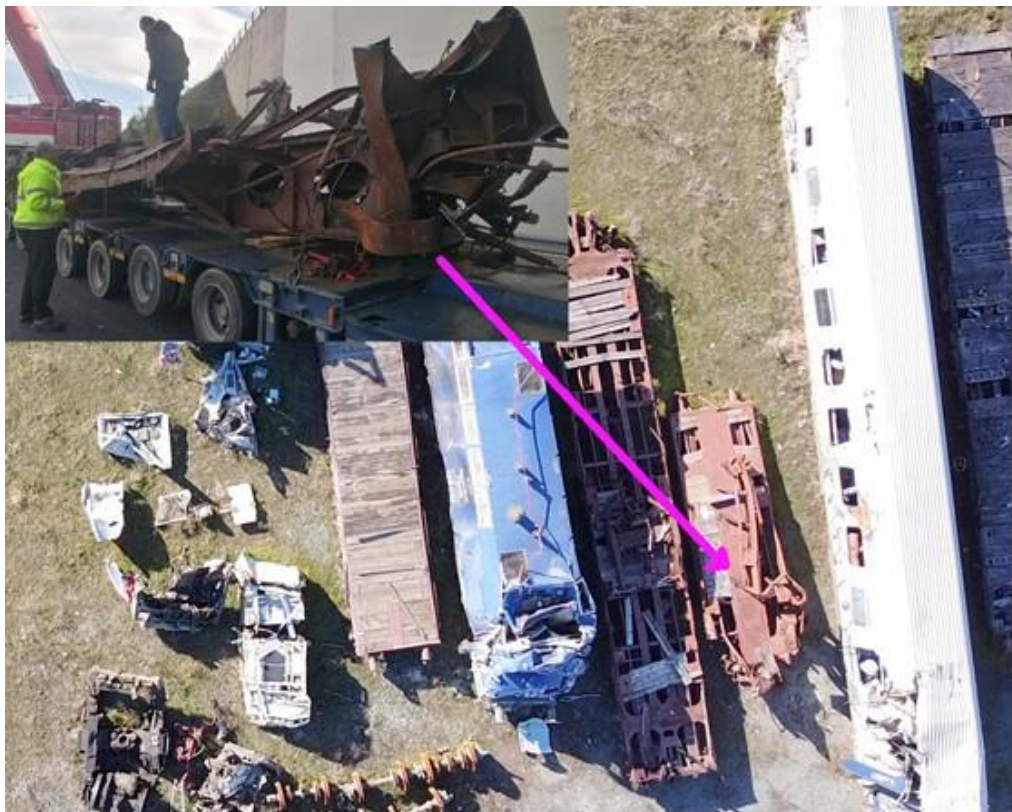
- 135 The rear part of the first platform wagon can be identified among the remains of the vehicles at Koulouri, but the front part is not available for examination, as it was presumably cut in smaller pieces in order to allow easy transport (Figure 19). This action was not documented in any way and there are no photographs of the carriage in its original condition at the crash site before being cut up and moved by an unknown party.

Figure 19. Remains of the first platform that was carrying steel plates.

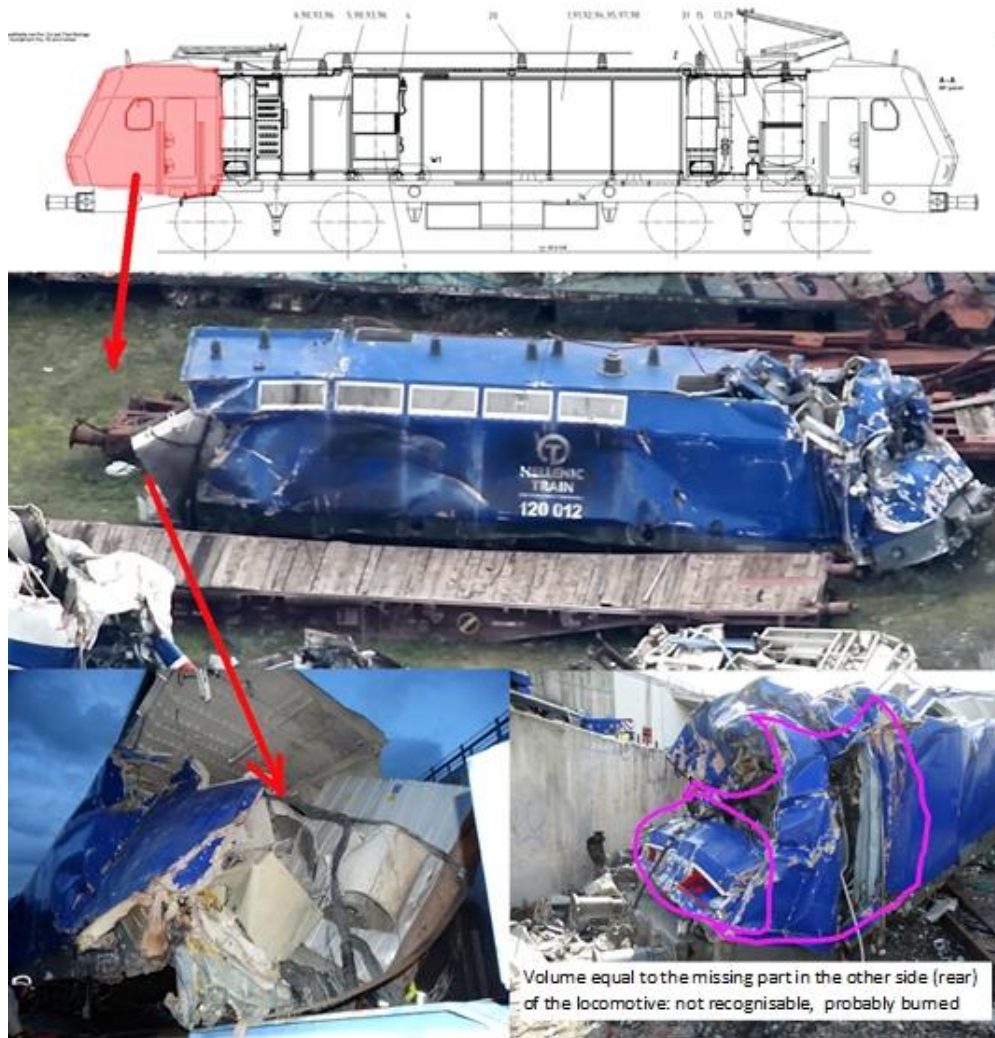
136 The rear driver's cabin of the 120-012 locomotive appears to be cut off from the rest of the vehicle and it cannot be completely identified anywhere among the debris, apart from a small part of its roof and top headlight (in front of the first container). The rest of the cabin cannot be identified as a whole and also the front panel with the painted number and the two red headlights are also not recognisable among the debris. Presumably, the missing structure is among the crashed and burned remains of the Restaurant Car, as this is the only place in the whole accident site where the fire burned so fiercely that it totally consumed the heavy industrial-grade paint of the blue locomotive, making it unidentifiable.

Figure 20. Missing rear-end of the locomotive 120-012.

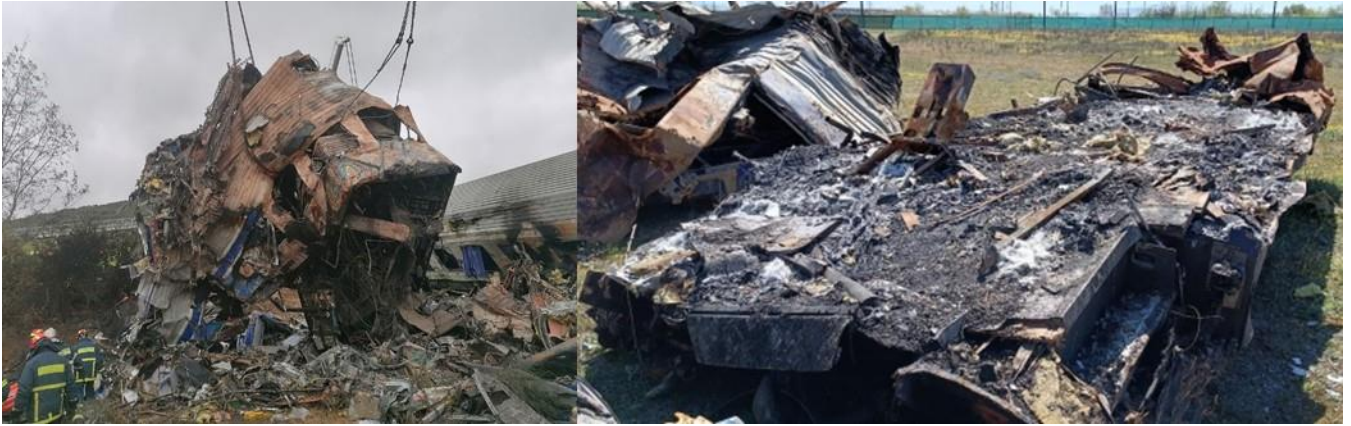
137 This second collision causes very heavy damage to the Restaurant Car (Figure 21) that is bent into an S-shape mostly due to this initial impact but also sustaining damage while rolling and hitting the ground on its way to the lower verge, to end almost on top of the remains of the locomotive 120-023 and the destroyed A1 first-class coach.

Figure 21. Remains of the Restaurant Car, on the left, S-shaped as found on-site, and on the right, its platform at Koulouri site.

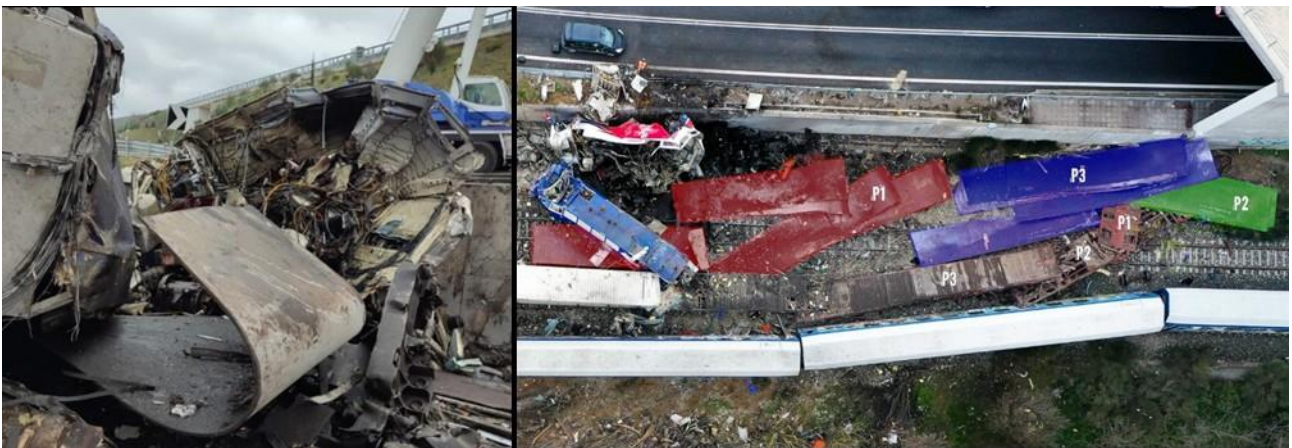
138 By comparing the damage to the steel plates and the Restaurant Car, it can be considered as most likely that the initial impact to the Restaurant Car came not on its front bumper but underneath its “belly”, indicating that the Restaurant Car had a slightly “nose-up” attitude at the moment of the impact, which is consistent with the damage observed on the first and presumably topmost steel plate that was found wedged underneath the blue 120-012 locomotive. Meanwhile, the 1st platform of the freight train sustains very heavy damage from the impact with the Restaurant Car that leaves it bent in half and wedged under the remaining steel plates against the wall, and spread few meters after the collision, in the area before the entrance of the tunnel. (Figure 13, Figure 22).

Figure 22. Remains of the top steel plates and final position of the 3 sets of steel plates.

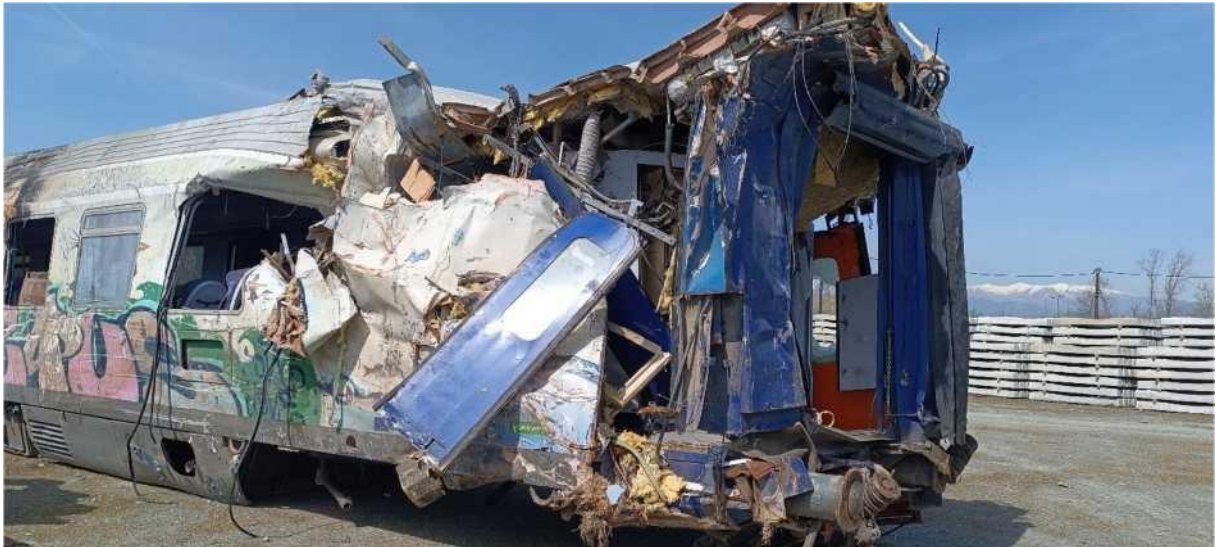
140 Derailed by the collision of the Restaurant Car, the B2 vehicle (a passenger coach divided into 11 6-seat compartments) continues straight ahead with a slight angle to the train tracks, nose diving downwards and hitting the ground with its front end, bending and breaking off its front section in the middle of compartment no 2. After the head-on impact, the rear of the wagon is lifted high and to the left and coming down to hit the front of the B3 passenger coach.

*Figure 23. Remains of the B2 coach*

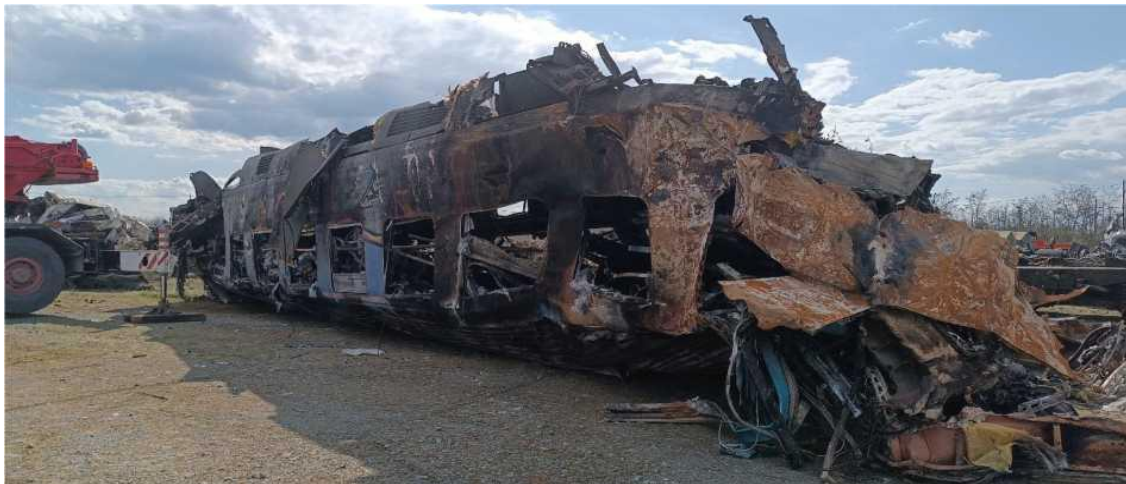
- 141 This B3 coach, in the meantime is derailed and veering to the left, its front end moving downhill and cutting down small trees and bushes, while its rear end is pushed straight ahead by the B4 coach (still attached to each other), creating a rotation to the left for the B3 carriage that comes to a stop at an angle when its side hits the debris of the A1 coach and the broken up Locomotive.
- 142 The impact of the B2 (Figure 23) on the top of the B3 wagon (Figure 24) causes the rear part (11th compartment) of the B2 coach to break off and fall below, while at the same time it causes severe damage to the B3 coach underneath.

*Figure 24. Remains of the B3 coach*

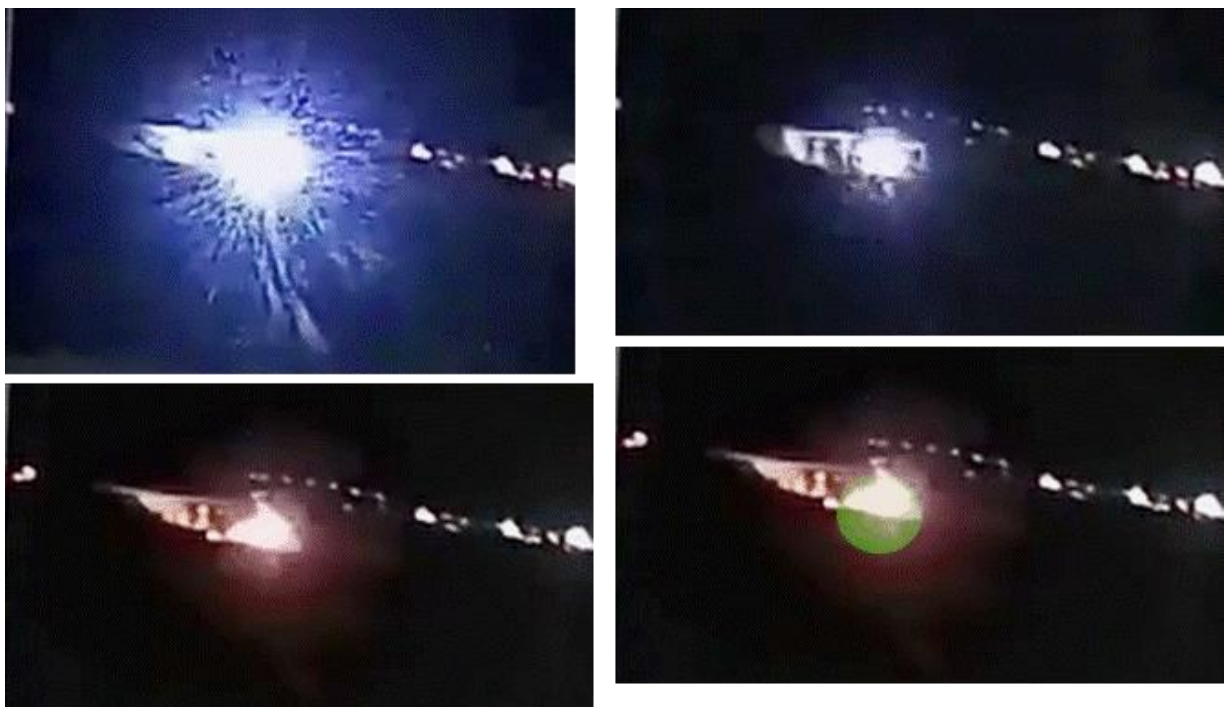
- 146 A first stage that can be observed, the ignition and creation of a fireball, starts at approximately 0.6 seconds after the initial contact between the locomotives of the two trains, when a first electric arc is being recorded on video. A short circuit is created with a bright flash due to the electric arc; and another 2 flashes appear rapidly after, each approximately 0.1 second apart. These 3 bright flashes stop after a total duration of about 0.3 seconds, which is consistent with the expected timing of the tripping of the automatic overload protection that was (manually) recorded at the power control station that remotely monitors all data at Thessaloniki.

Figure 27. First stage, arc flash and ignition. The green circle shows the theoretical expansion radius of the initial deflagration.

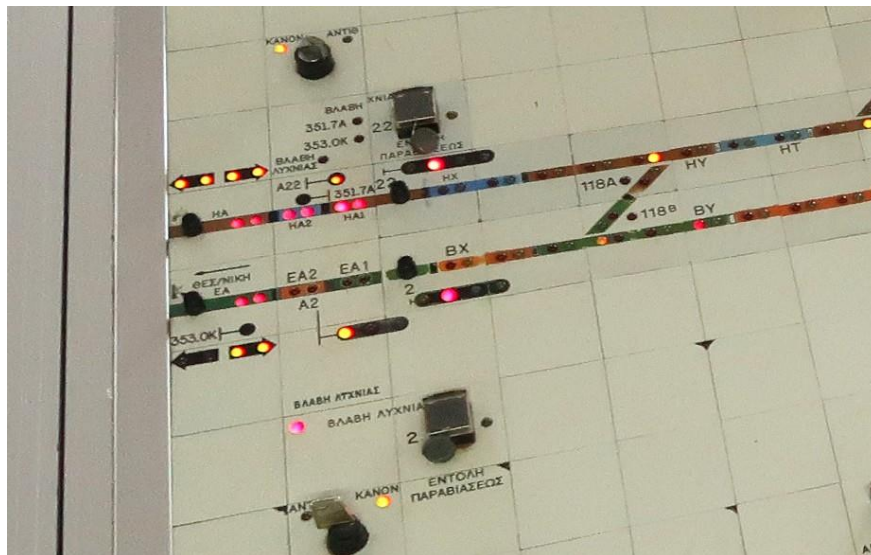
Figure 49. Section EA3 (indicated EA to the left of EA2 on the picture) of the control panel incorrectly indicating an occupation.

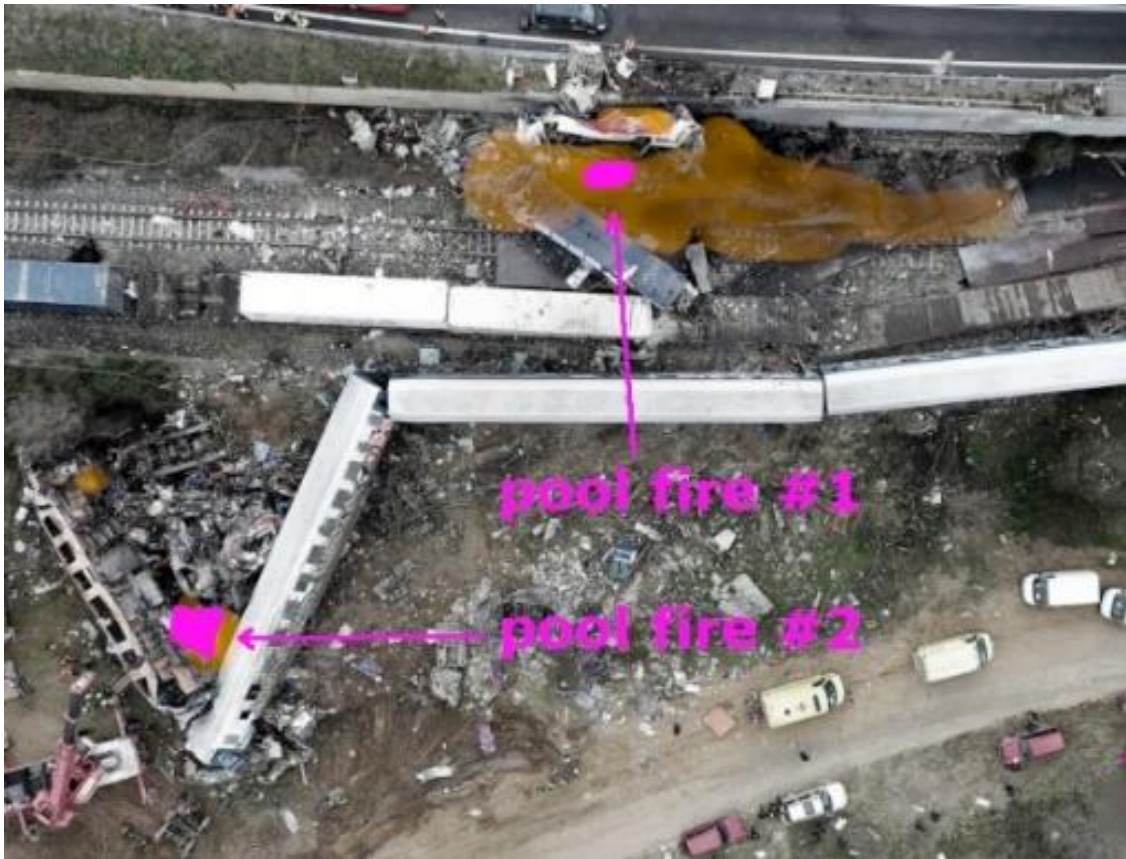
Figure 63. Location and approximate size of pool fires #1 and #2.

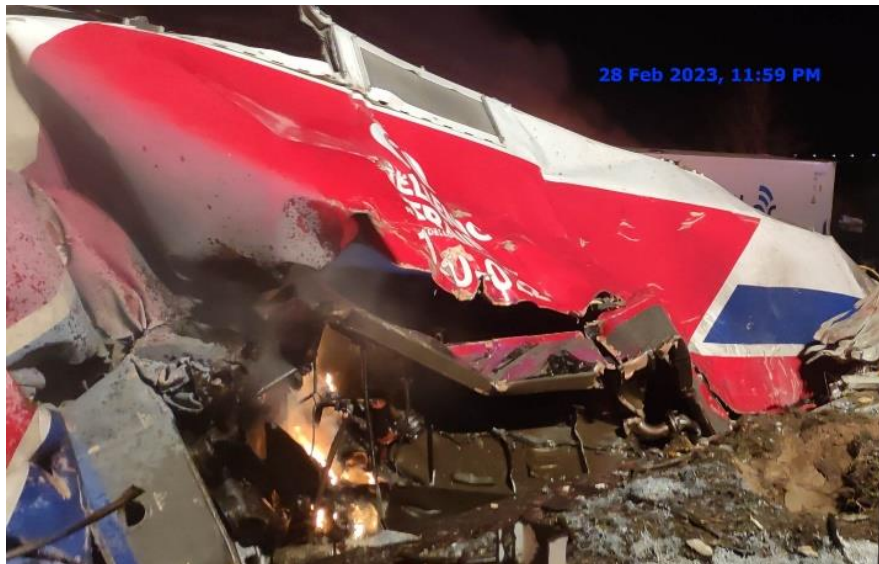
Figure 65. A local fire inside and outside the broken transformer of the first locomotive of the freight train, 40 minutes after the accident.

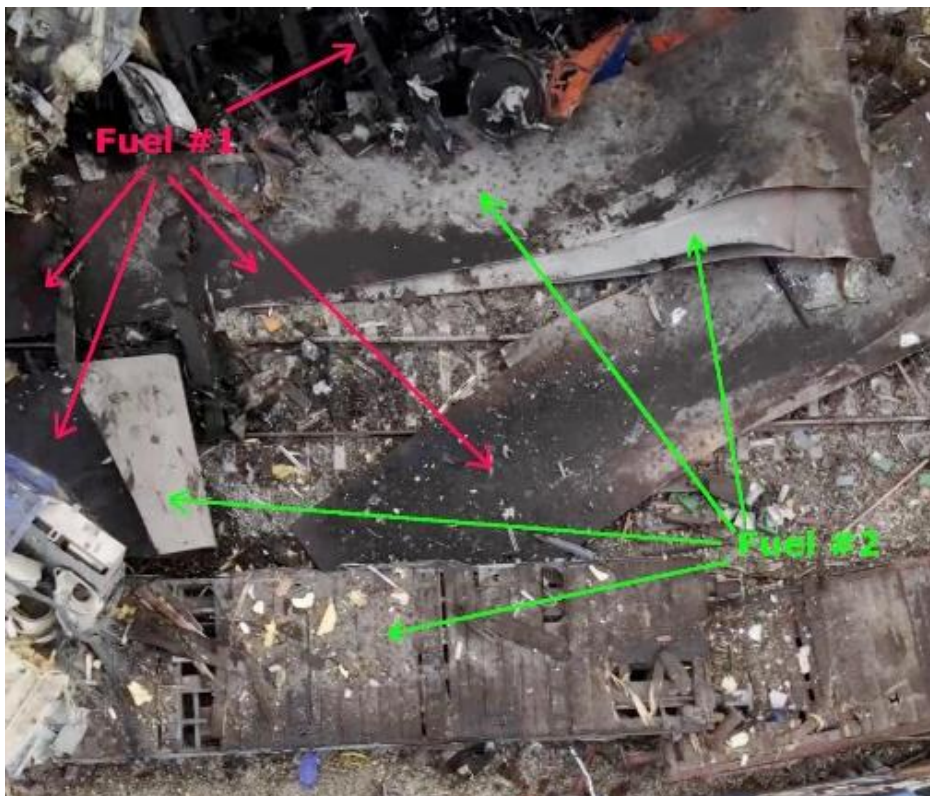
Figure 66. Evidence of two different fuels burning in the pool fire #1, one leaving black, the other leaving white residue.

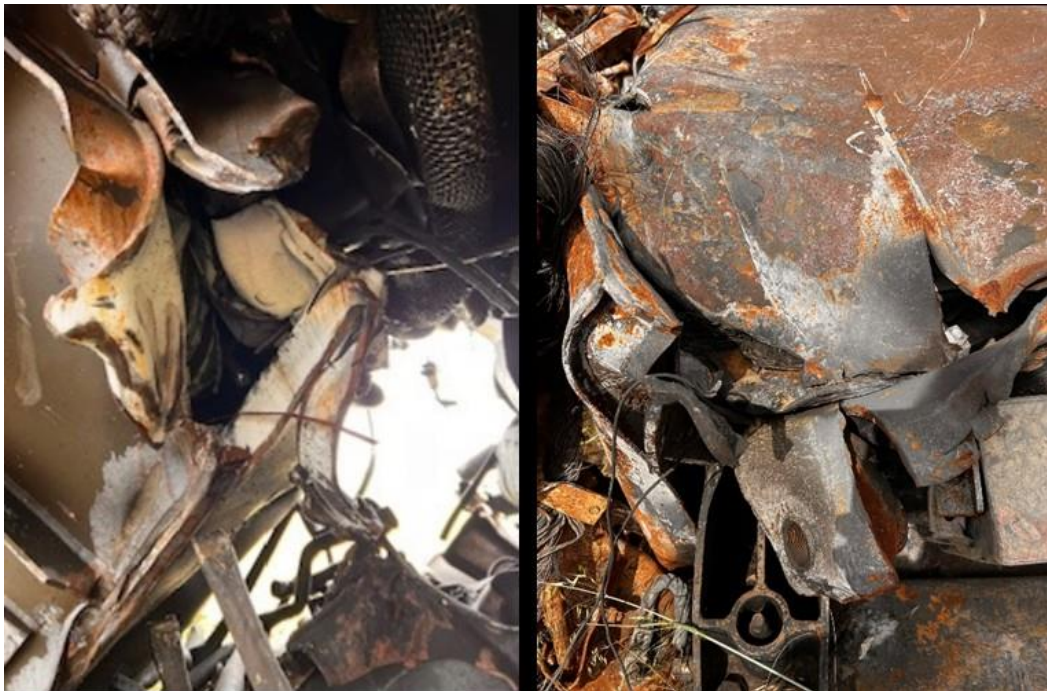
Figure 67. Large cracks of the transformer still attached under the 120-022 locomotive (Left). Bumps, folds, rips and large cracks of remaining locomotive transformer 120-023 (right), see also Figure 61.

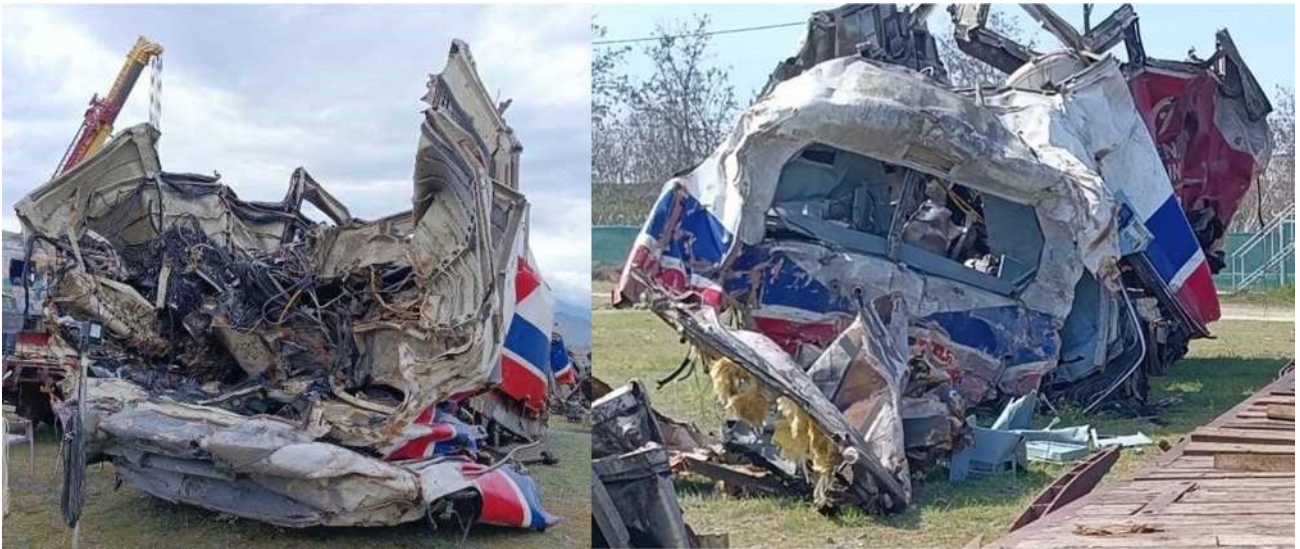
Figure 77. Position 1) Siemens Hellas Sprinter 120-022- NVR Engine: 91 73 212 0 022-7 Extreme damage on the front, roof missing, and rear heavily damaged from the rear collision with the attached locomotive 120-012. Rear view in Figure 14.

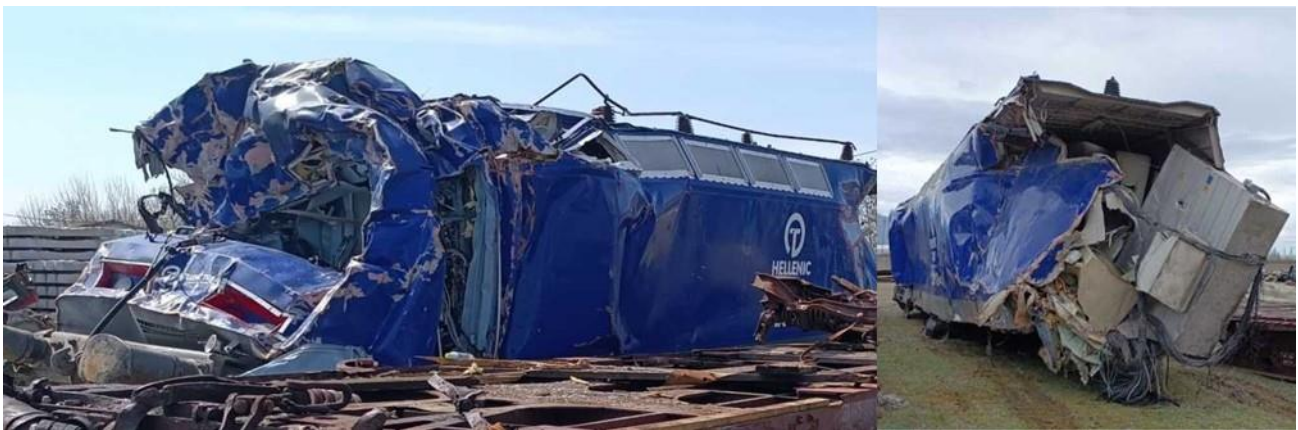
Figure 78. Position 2) 120 012 locomotive, heavy damage in the front (with locomotive 120-022) and rear, signs of crash against 1st container on P4, without the missing rear cab.

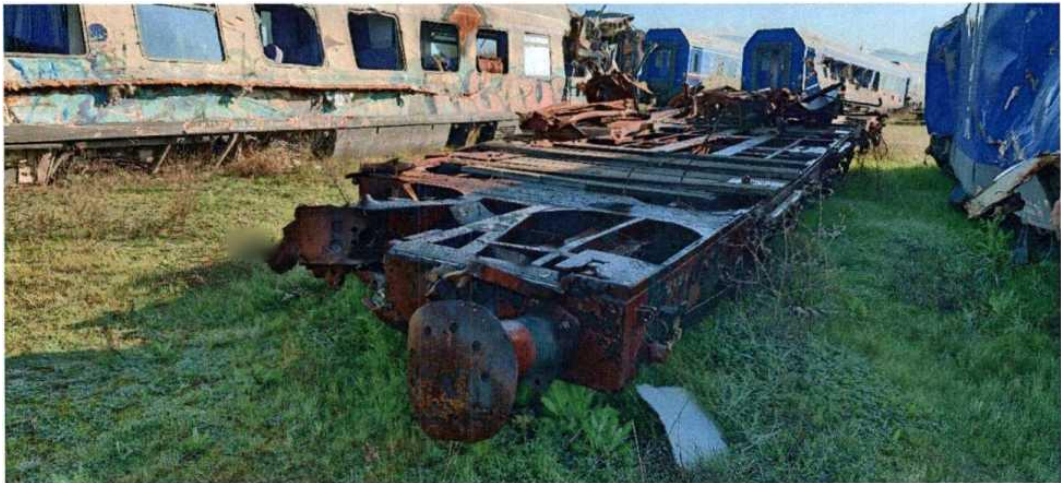
Figure 79. Position 3) nr 1 platform carrying steel plates, front half totally destroyed by heavy impact with Restaurant Car.

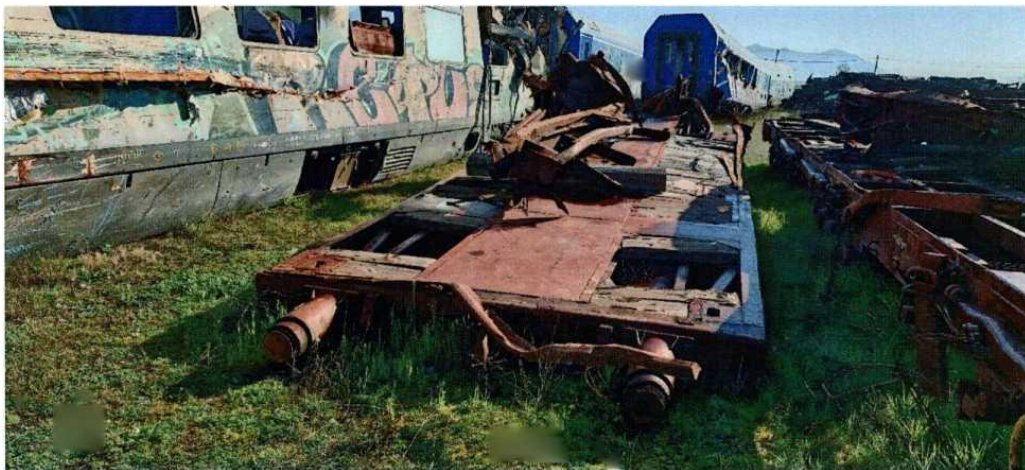
Figure 80. Position 4) nr 2 platform carrying steel plates, lost bogies from derailment but very slightly damaged, no signs of heavy crash.

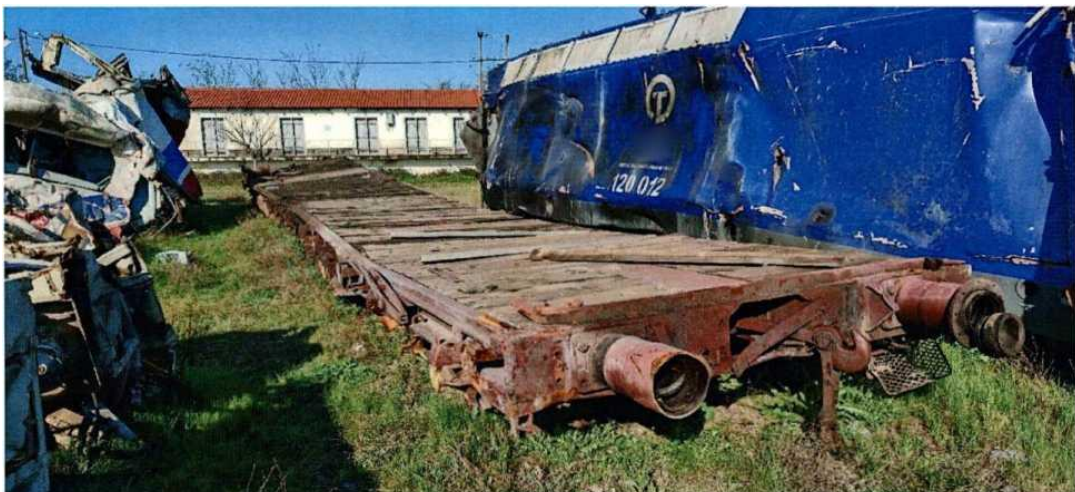
Figure 81. Position 5) nr 3 platform carrying steel plates, lost bogies from derailment, slight damage (twist) due to crash from the rear.

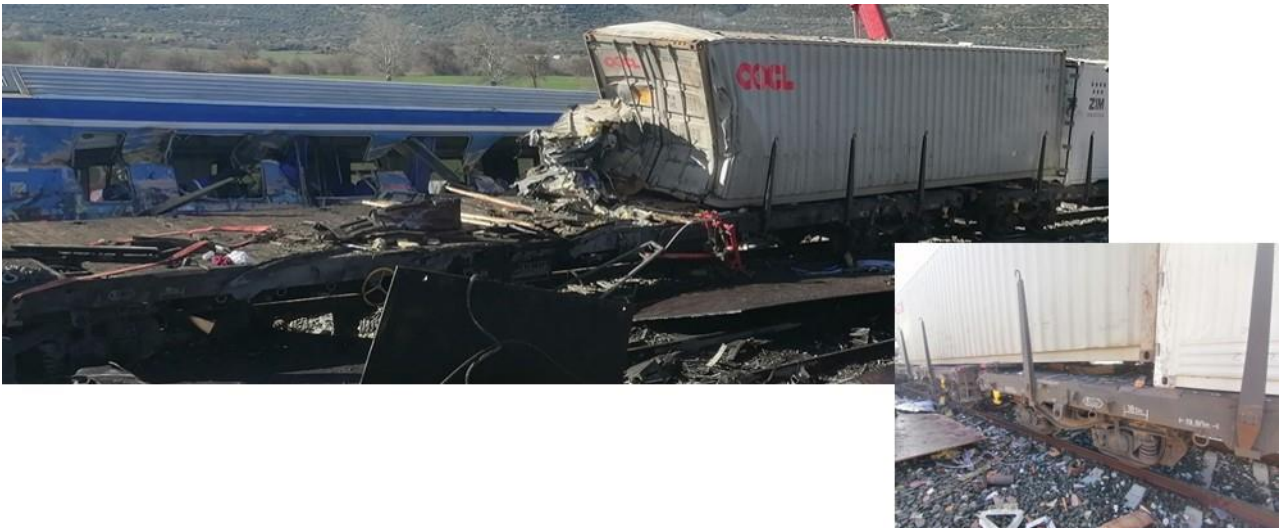
Figure 83. Positions 6) and 7) – on the left, the platform nr 4 (damaged, lost front bogie, not derailed) carrying the first container. On the right, the first container (OOCL) is shifted in rear direction, hurting the next container (ZIMonitor).

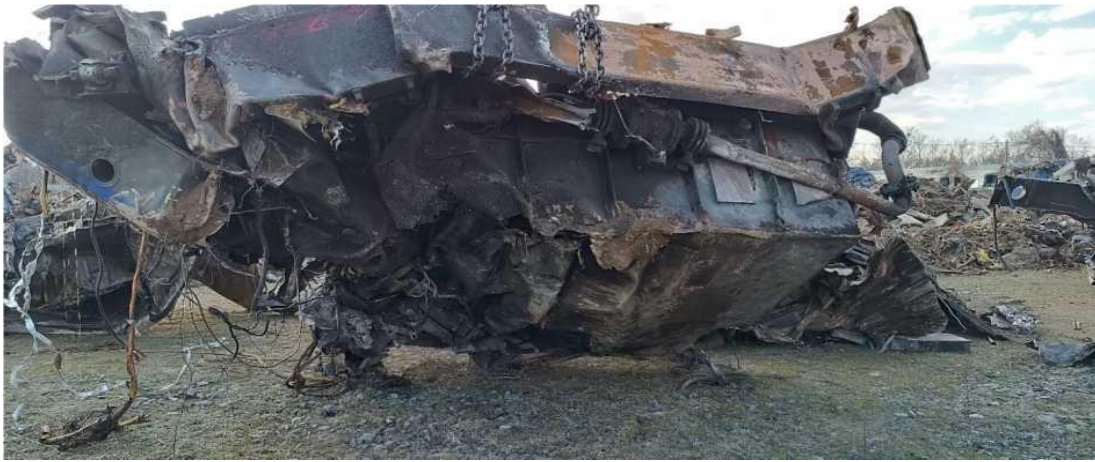
Figure 85. Position 1) 120 023 locomotive, totally destroyed, broken into large pieces. Remaining piece of the basement platform. Part with transformer still visible. Other side in Figure 17. At the position 2) the A1 1st class coach, totally destroyed, has broken into small pieces, and was not recognisable as a whole vehicle.

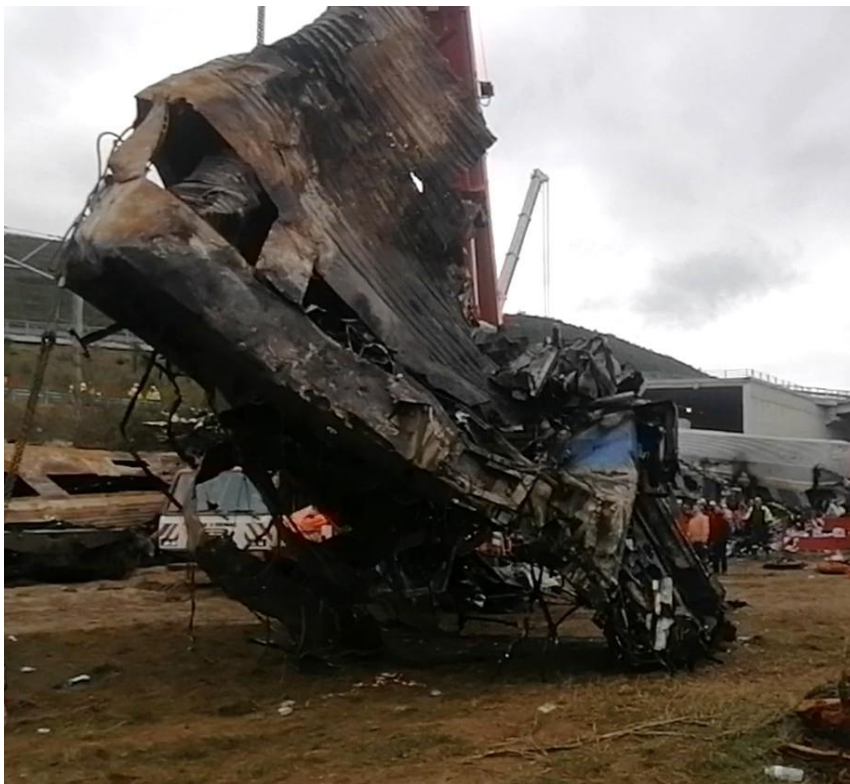
Figure 86. Position 3) Restaurant Car, very heavily damaged from initial crash (folded, bent into S-shape) and burned down. Here, suspended from the crane cables.

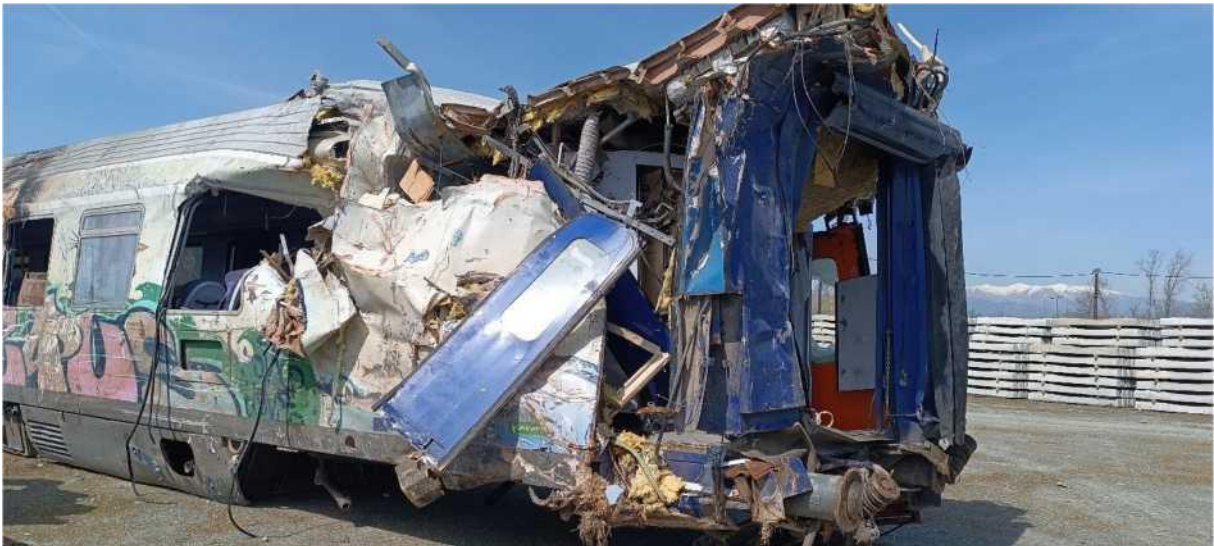
*Figure 88. Position 5) B3 2nd class coach, derailed and went down a slope, lost bogies, no other damage from derailment or crash, specific impact damage from B2 coming down from above.*

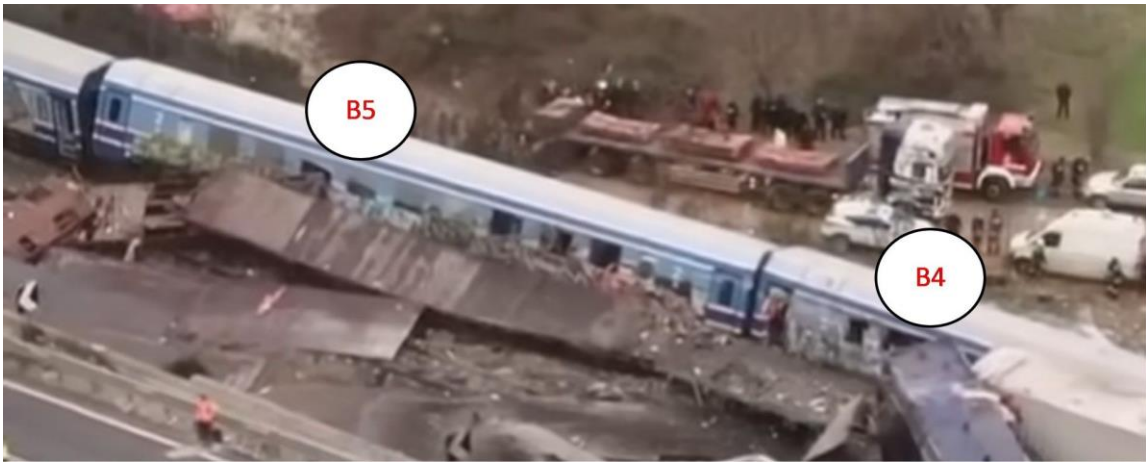
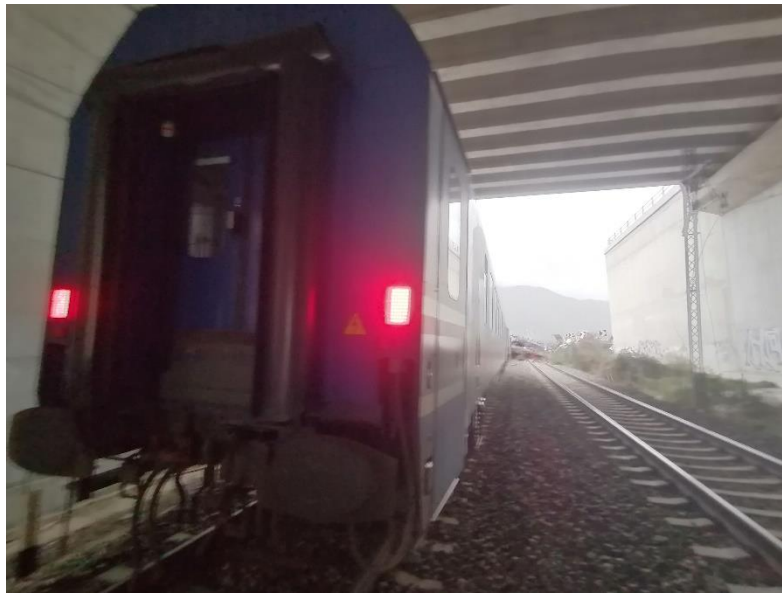
*Figure 89. Positions 6-9) B4-B7 coaches, B4 and B5 derailed and were hit on the side by steel plates, B6 and B7 did not derail, no damage, B7 remained nearly all in the tunnel.*
