Rail Accident Report

Head-on collision between a passenger train and a freight train  
in Tempi, 28 February 2023

RL01-2025, 27 February 2025

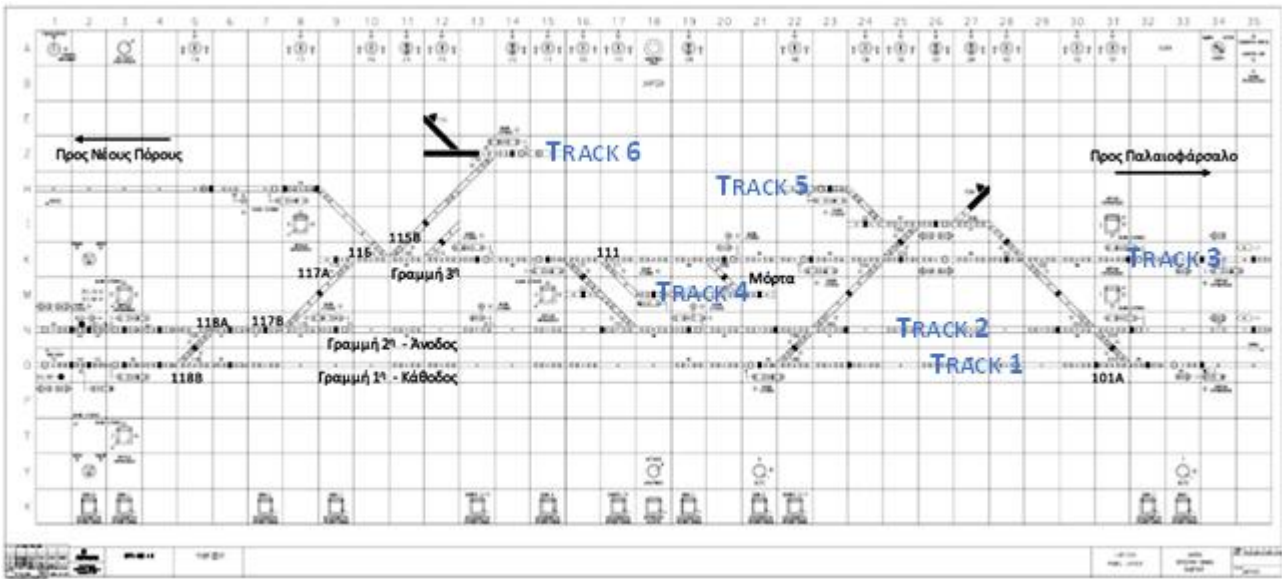
Figure 5. Scheme of the tracks at Larissa station as schematised on the control panel at Larissa Station

- 89 Within the Larissa station there is a signaling system which is controlled through a Control Panel placed in the station master's office. On the control panel the layout of the lines and switches are shown in a schematic form. It also depicts the indications of the light signals for the station, the position and locking status of the switches, the possible alignment of a route and the presence and position of the trains as soon as their first axle enters the track circuits.
- 90 The track type is UIC 60, continuously welded. The line is double track with standard gauge (1435 mm). The movement of trains is done via electrification (Airborne System with AC 25 KV). Communication between station masters is done via GSM-R and between station masters and train drivers via radio (VHF). No Train Protection System (ETCS or other) was operational.

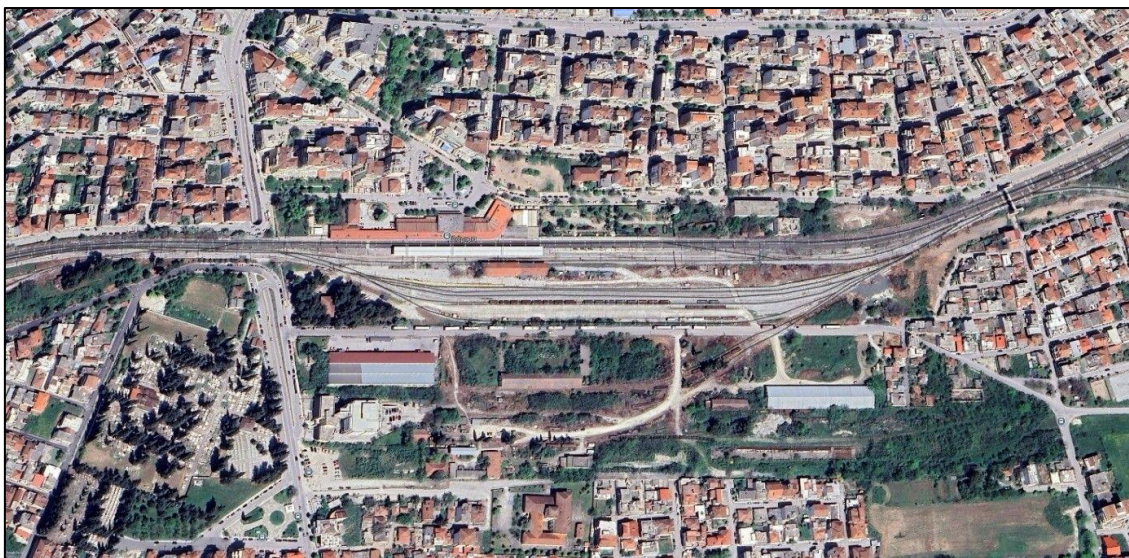
Figure 6. Railway map of Larissa Station (from Google Maps, 04/2023)

- 91 The signaling at the exit of Larissa station to Thessaloniki was not operational, because the renewal works (covered by contract 717) were only partly realised. As a result, the signal LAR11 to exit Larissa station towards the north was continuously showing a stop-aspect. Consequently, the station masters working in Larissa had to personally give the order to the train driver (written form 1001 or telegram<sup>3</sup> via VHF-Radio) to pass the red signaling in order to continue towards the next manned station Neoi Poroi.

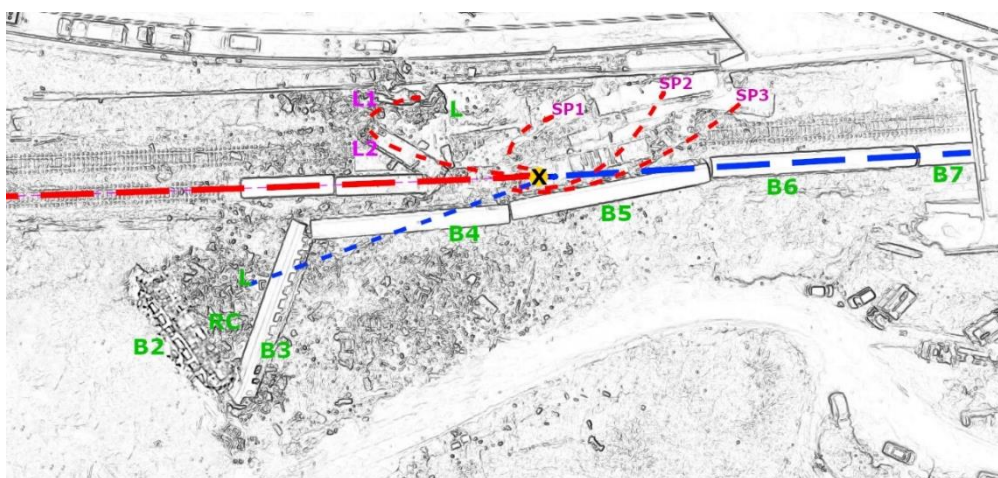
- 130 The 1st phase mainly involved the first 4 vehicles of the two trains: 2 locomotives 120-022 (first) and 120-012 (second) of the freight train and the locomotive 120-023 with its first-class A1 coach. The initial impact is a head-on collision between passenger train locomotive 120-023 and the first freight train locomotive 120-022, that causes the latter, along with the second locomotive 120-012 to be catapulted towards their left over the upward line track and smashed against the motorway wall, with the second locomotive making a U-turn and its rear end sliding over the steel plates carried on the 3rd platform of the freight train to come to a standstill with its front side against the first locomotive and its rear end resting against the first shipping container carried on top of the 4<sup>th</sup> platform of the freight train (Figure 10, Figure 11, Figure 12).

Figure 11. Global movement of the collision, with the initial impact and catapult effects. (SP1,2,3 are Steel Plates, and were also catapulted)

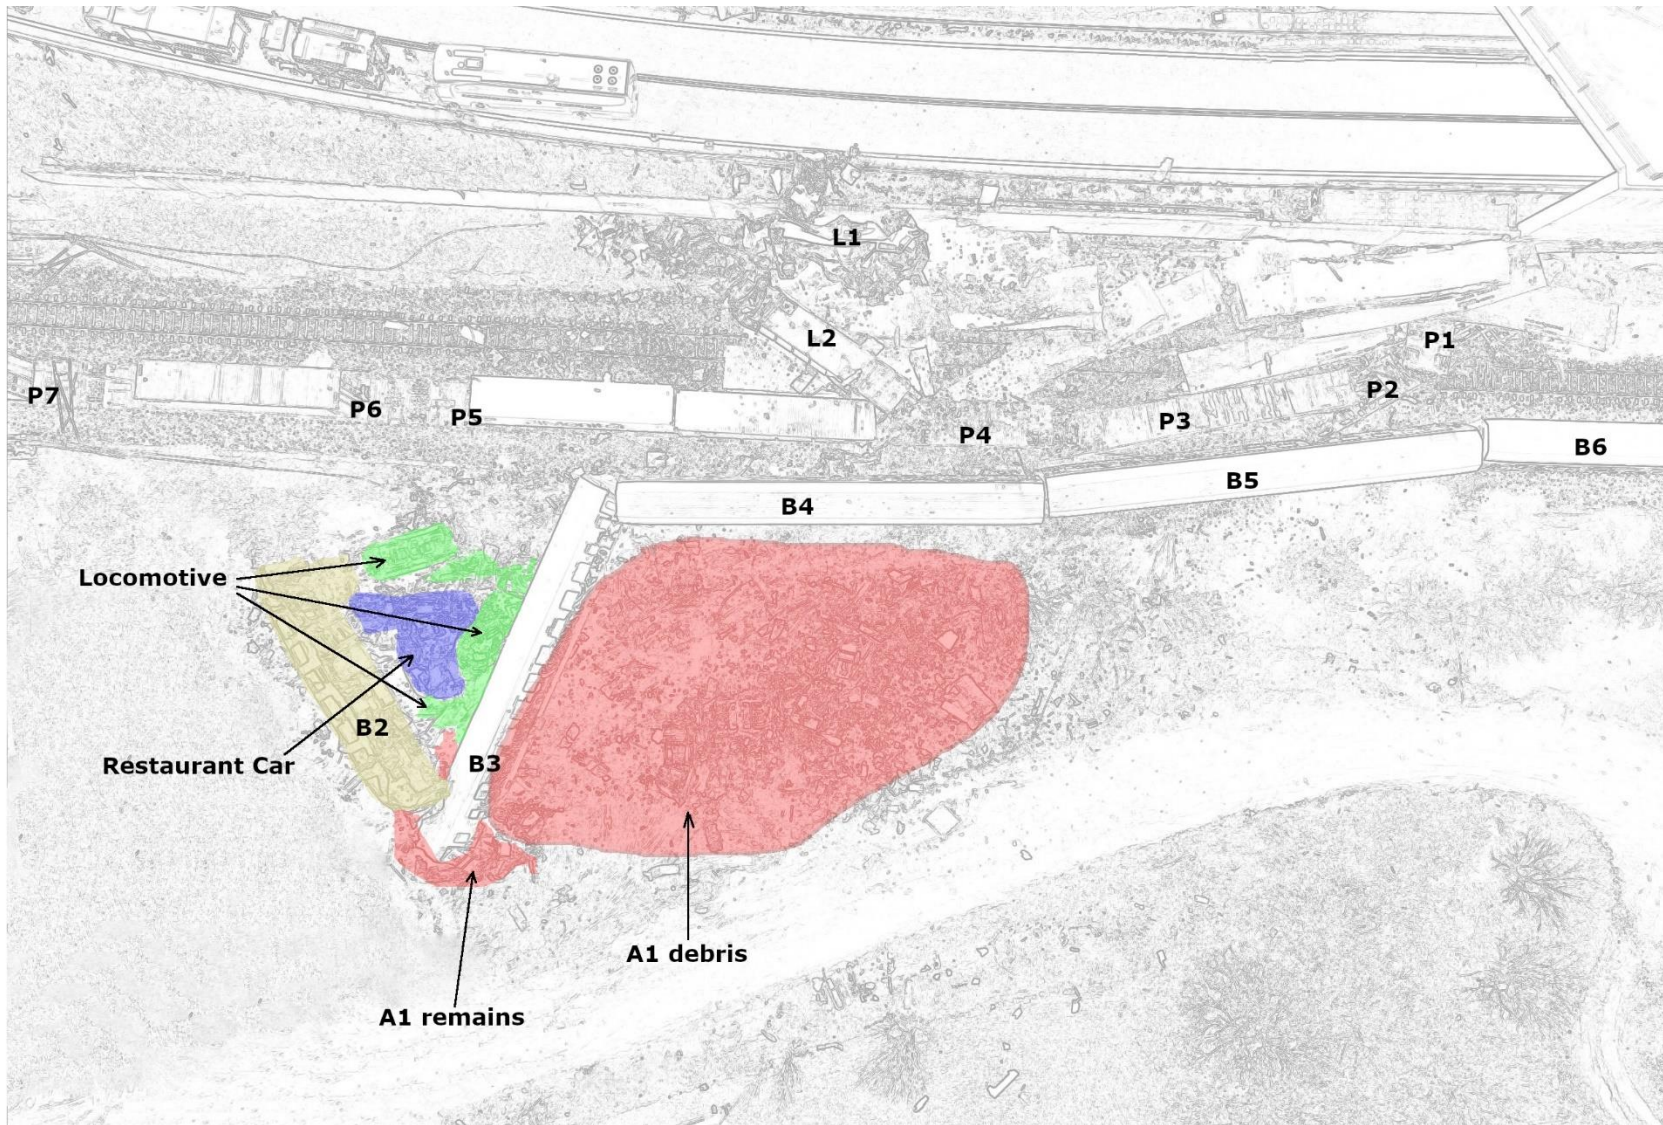
Figure 12. The accident site.

Best estimated point of the 1<sup>st</sup> collision: X, Freight locomotive 120-022: L1, and 120-012: L2, Passenger train locomotive 120-023: Locomotive areas, First-class A1 coach: A1 areas, Restaurant Car area, Second-class B2 on B3 head, then B3, B4, B5, B6, (B7 under the tunnel), Freight train platforms P 1-2-3-4, and freight wagons 4-7 (and other 6 not on the figure).

- 132 The passenger train locomotive 120-023 follows a slightly leftward path in its driving direction towards the lower verge, where it hits the ground, followed by the first-class passenger car. Due to the very heavy initial impact, this 120-023 locomotive has been completely destroyed (Figure 17), and its parts were found at an angle of approximately 20 degrees to the left and at a distance of 30 to 45 meters. The A1 coach of the passenger train was completely broken up due to the extreme mechanical loads of the impact and its heavier parts followed a path close to the path of the locomotive parts, at an approximate angle of 25 to 30 degrees to the left. Its lighter parts (seats, internal panels and fittings, luggage, and all casualties) were scattered in a wider area before the end position of the vehicle (see global Figure 12).

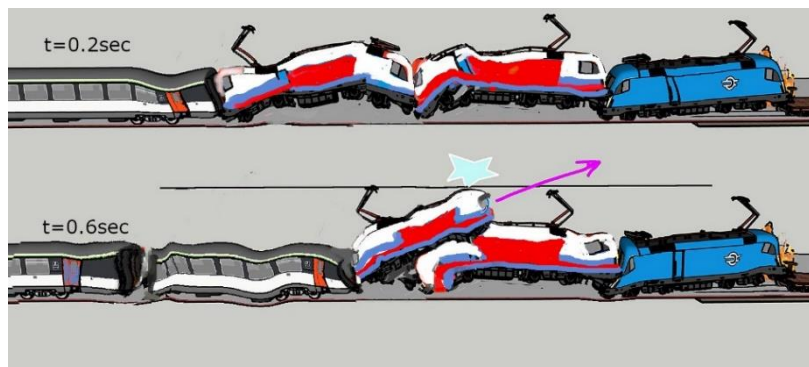
- 131 From the examination of the remains of the first freight train locomotive 120-022, it is clear that the head-on collision bent the front bumper downwards and inwards (Figure 14, Figure 15), severely bending the heavy beams of the lower frame of the locomotive, while at the same time the fact that the roof is missing (Figure 16), is an indication that the passenger train locomotive 120-023 passed over and through the roof of the this 120-022 locomotive.

Figure 15. Movement of the passenger train locomotive 120-023 over and through the roof of the freight train locomotive 120-022.

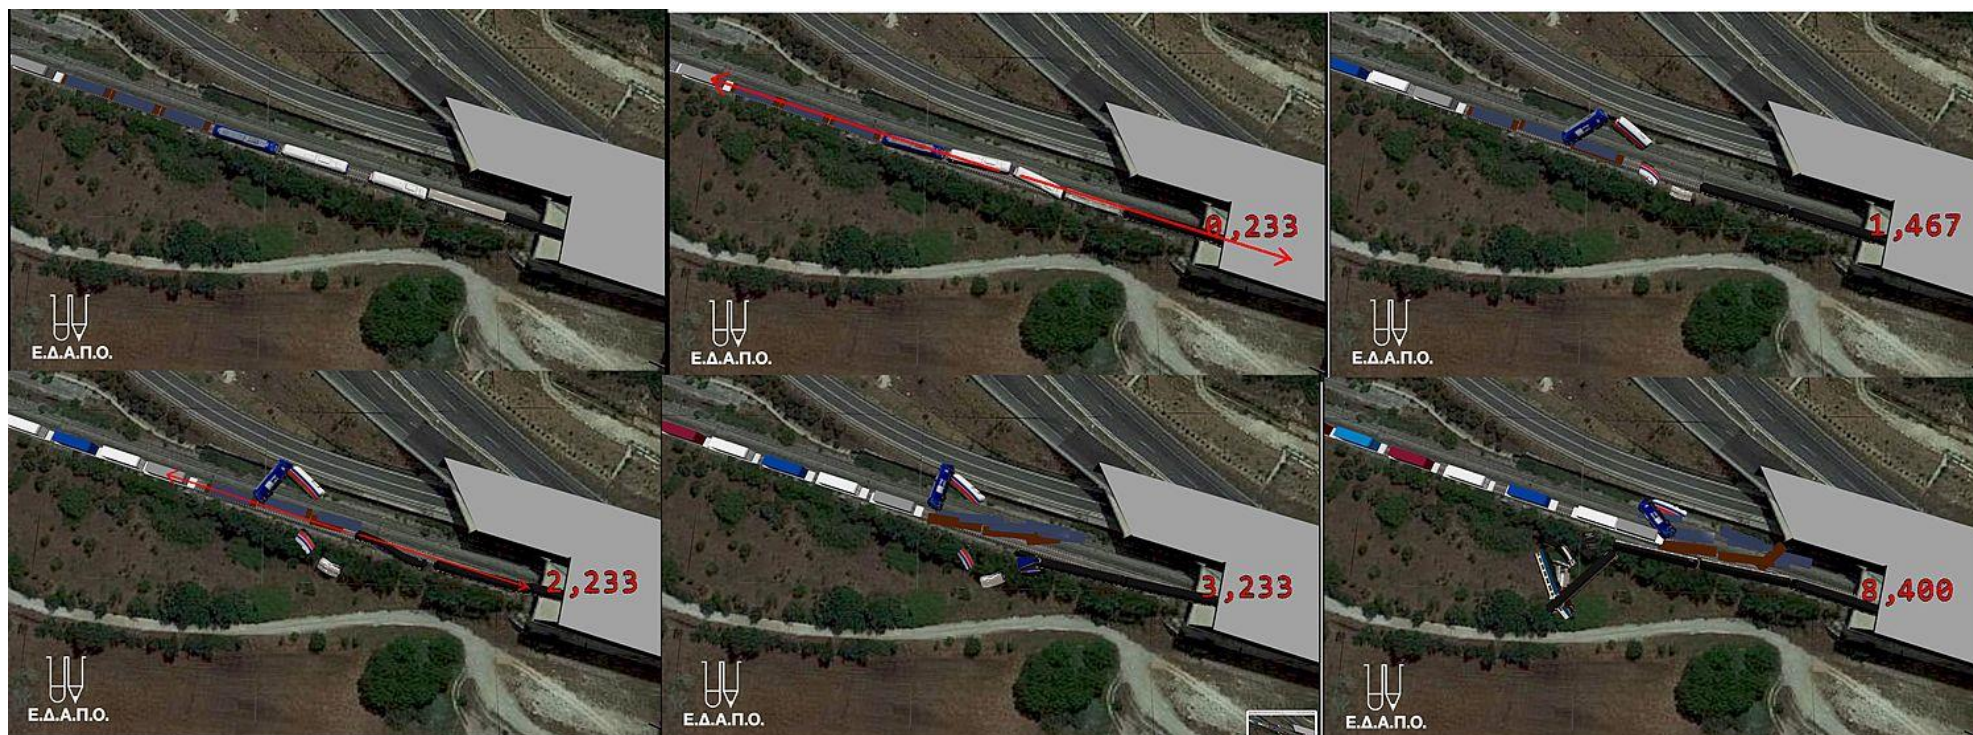
- 144 Finally, the fourth wagon of the freight train carrying a shipping container, hits the second freight locomotive 120-012 and then comes to a standstill. On the next page (Figure 26), a set of pictures extracted from an animated sequence proposes an overall view of the collisions with their timestamps: image 2 showing the 1st impact, image 4 the 2nd impact and images 5 and 6 the movement till standstill.

Figure 26. Overall view of the simulated accident mechanism with the timestamps: image 2 showing the 1<sup>st</sup> impact, image 4 the 2<sup>nd</sup> impact and images 5 and 6 the movement till standstill.

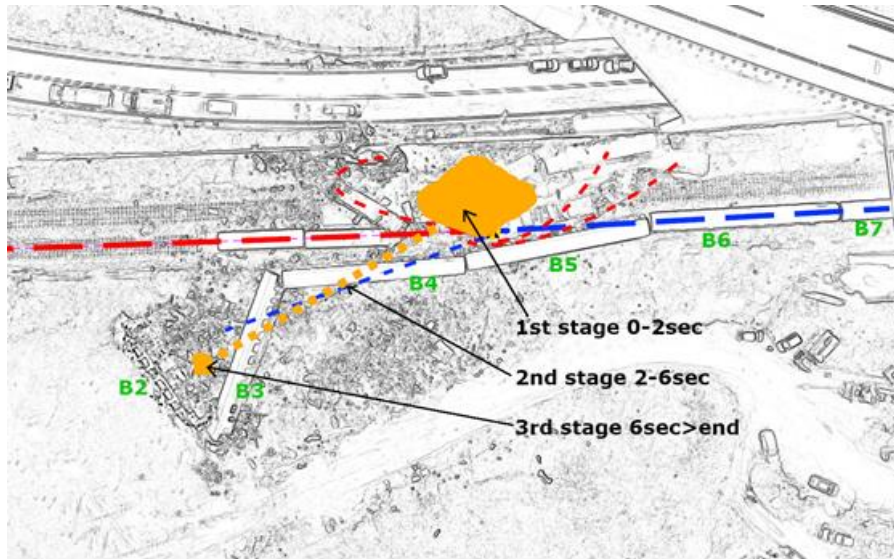
- 147 At the same time, the catenary lines themselves (both lines, one for each direction of travel) have been ripped off due to the collision, but the power was already cut within 0.2-0.3 seconds of the short circuit. Approximately 0.3 seconds after the end of the arc flashes, a fireball starts forming from the ground level and very rapidly expands upwards to a size of approximately 42 meters in diameter, which burns for approximately 2 seconds.
- 148 At approximately 2 seconds after the initial ignition, a second stage starts, when a new fire plume can be observed, moving northbound, away from the 1<sup>st</sup> stage fireball. This new fire plume is feeding the original fireball until it grows to almost double the size (80 meters) at approximately 4 seconds after ignition (Figure 28, Figure 29, Figure 30).

Figure 30. Clarification of the sequence with its timing.

- 439 As described before (3.9.3), observing the course of the fire gives rise to making a distinction between 3 different stages (Figure 30, page 47):

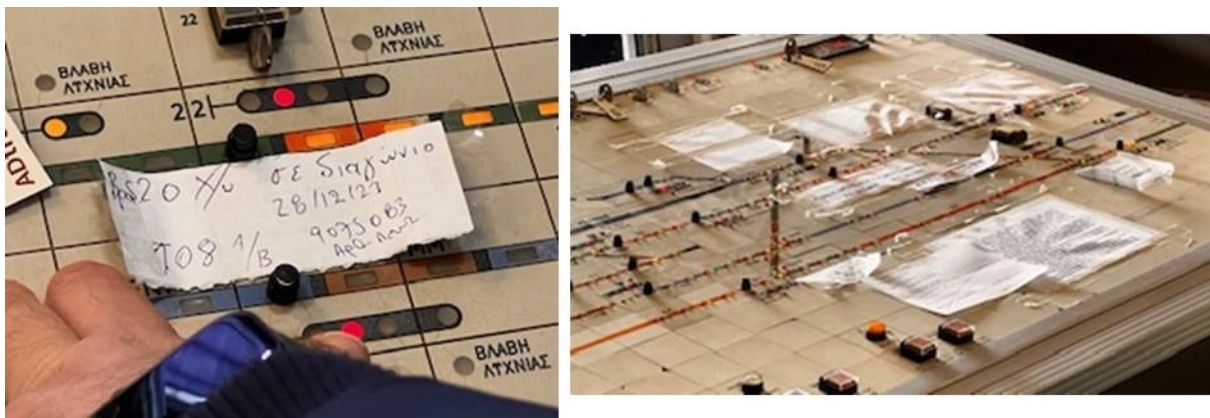
191 The Larissa control panel in the station masters' traffic control room, as well as others in actual operation (Figure 40), is supplemented by pieces of paper "taped" or just "laid" on the inclined panel. Their operational function is to remind the station masters of important local information on operational restrictions or degradations, some for a few hours, others for months (and even longer).

Figure 40. Useful pieces of information.

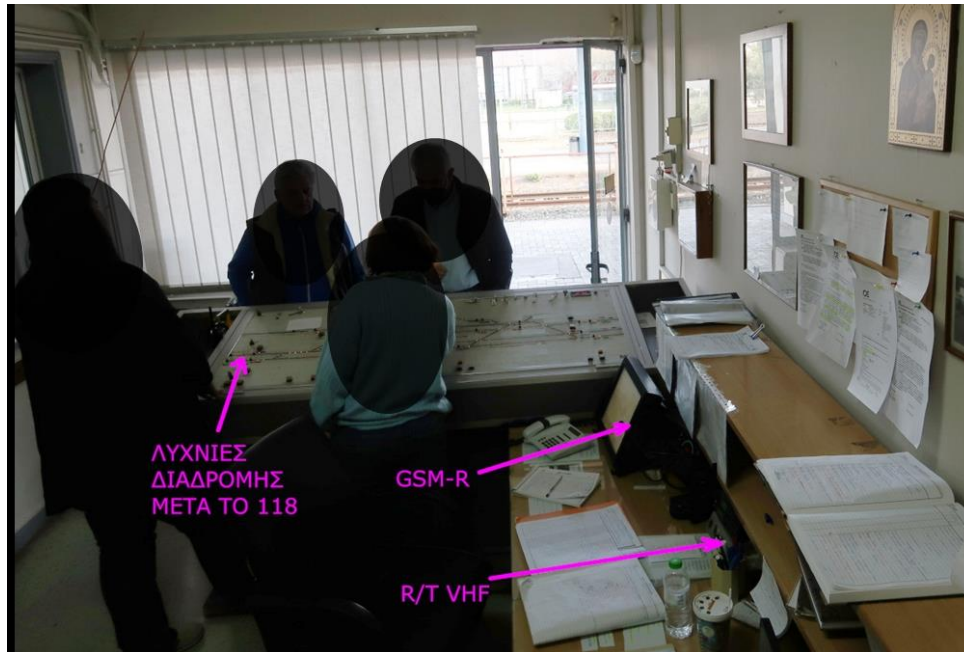
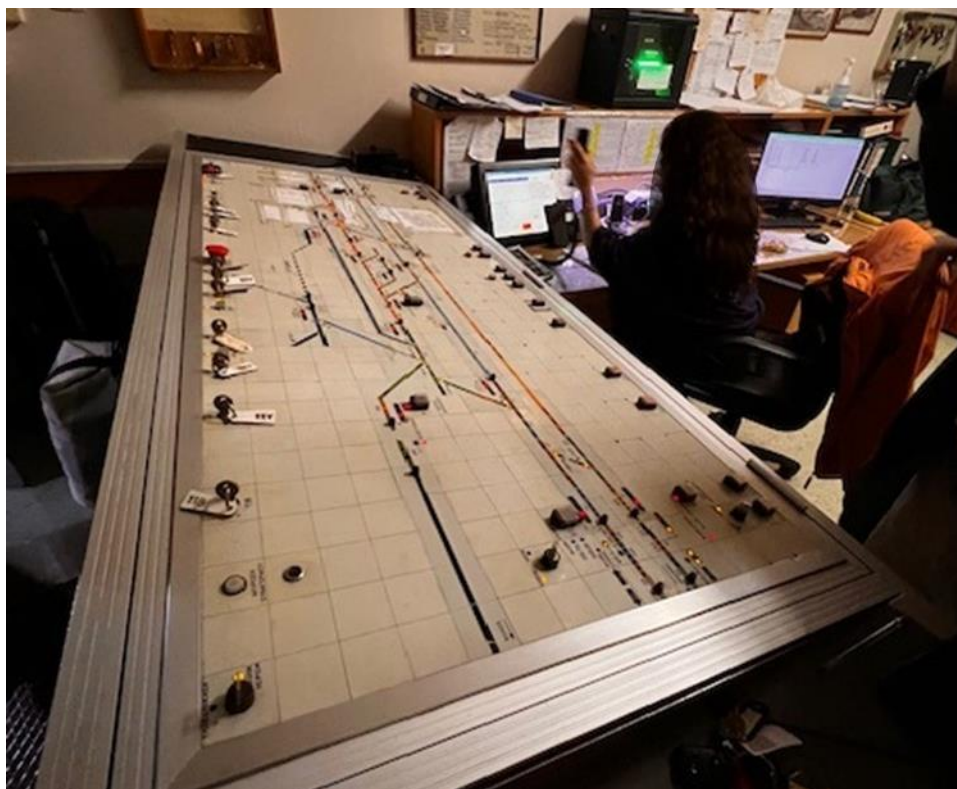
Figure 41. Positions of station masters when facing the control panel (above) and when communicating (below) in Larissa station.

192 Taken together with another source of influence, namely the numerous communications (as analysed in point 4.2.1.8), in the period of time just before and while the control panel was showing the passage of train IC-62 (240), it should be noted that this panel and the communications area are organised and physically positioned in a way that makes it very difficult to perform both tasks at the same moment. In morning and afternoon shifts these tasks are performed by two station masters in order to avoid excessive workload. When you are concentrating on communications, you are turned sideways in relation to the control panel and the LEDs that are lit in this case are behind you (Figure 41. Positions of station masters when facing the control panel (above) and when

193 ). This directly, logically and naturally explains how Larissa's station master did not 'see' or 'look', and therefore did not 'detect' the train's passage towards the descending track (4.2.2). During the investigation, 2 other situations were identified by the investigation team: one in which the station masters had adapted it and added a desk just in front of the control panel (Figure 42), and the other one, in Athens, when a Station Manager reported this as an issue and their manager made the situation more adapted.

- 245 Furthermore, the way the communication means (VHF console, GSM-R and telephone) are positioned on the right of the control panel and at a lower level (Figure 41). This means that, when occupied with whatever communication and logically directed towards the used means of communication, the indications related to the position of switches 118 and the departure of train IC-62 were situated behind the left shoulder of the station master in the left bottom corner of the control panel and so in practice invisible (192).

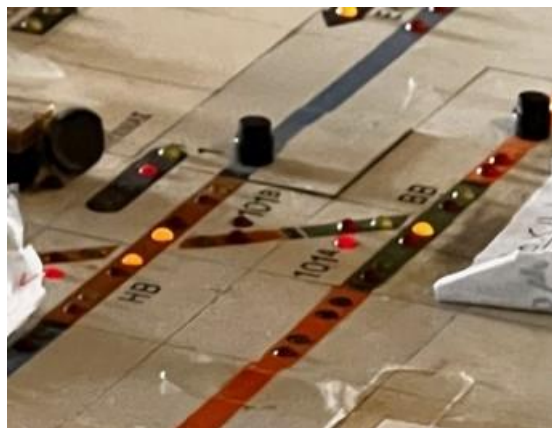
Figure 43. Switches 101A/B

- 214 Due to a problem with the overhead line that occurred earlier that day, traffic between the station of Paleofarsalo and Larissa was operated on a single line (92). This requires additional attention as well as specific communication between both station masters. Furthermore, this also requires an additional action for the trains that enter Larissa from Paleofarsalo from the descending track because the switch-combination 101 had to be turned into the bypass position to allow them onto track 2 in Larissa station (Figure 43).

- 215 Due to technical problems the switch 101A could not be operated remotely (94, Figure 43), via the control panel. To be able to maneuver the switch in the desired position, the station master has to instruct the local switch operator who in turn has to walk towards the switches and fix them in the requested position with a physical intervention. The station master in Larissa instructed the local switch operator at 22:46 to position switches 101 in a bypass position, directly after being informed by the station master of Paleofarsalo that train IC-62 had left for Larissa. At 22:57, the switch operator informed that the activity was performed.

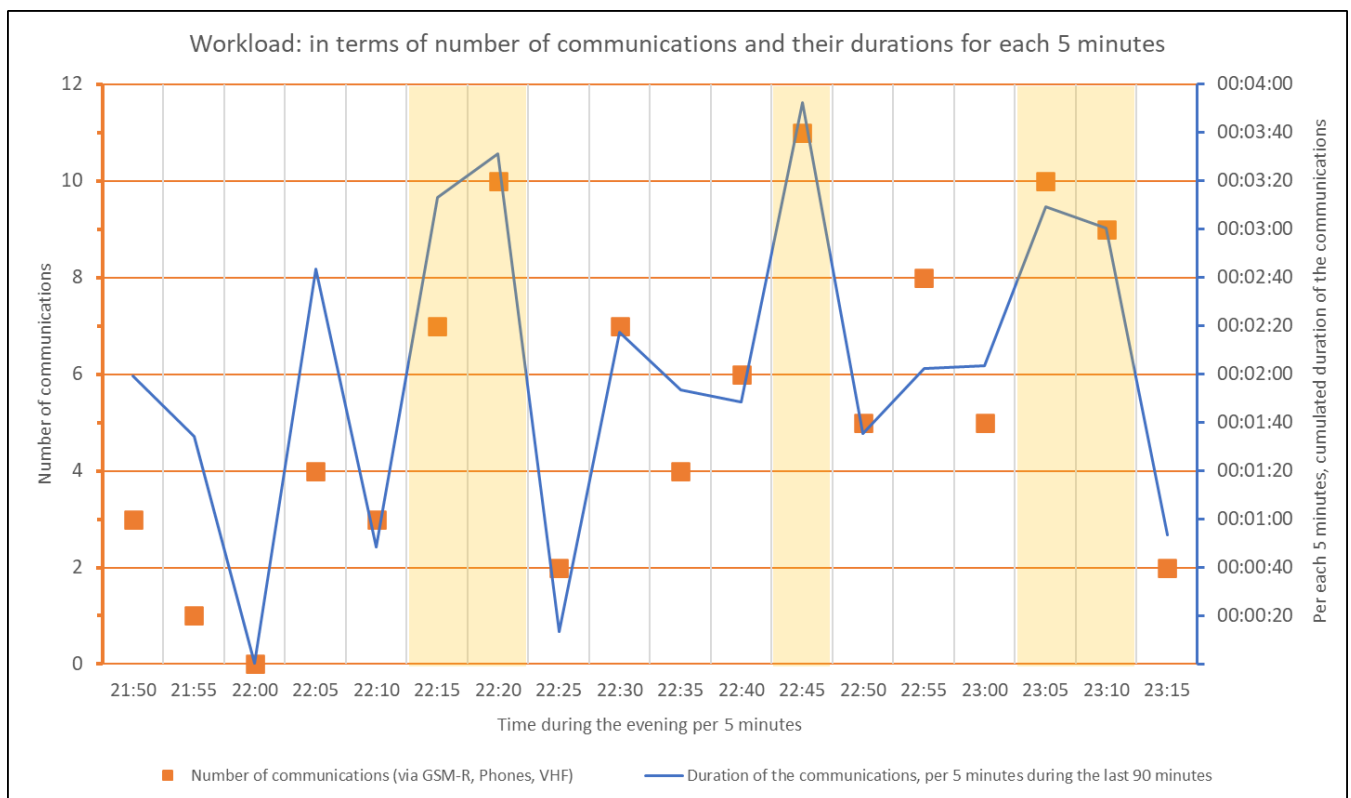
Figure 44. Factual analysis of the communication workload as a risk to be taken into account during HOF integration.

- 220 Analysis of only the communications, not even taking into account other tasks, indicate three peak periods (Figure 44) that appear to correspond with the consecutive mistakes made by the station master: setting the routes for respectively the train 2597 and IC-62 and not detecting the mistake with switch 118. This indicates that periods of too heavy workload, in particular for less experiences operators, can be a direct cause for errors, mistakes and routine violation, because there is “no-time-to-think” or one is “captured-by-the-flow-of-issues-to-contain”. This type of workload analysis, with results beyond human capabilities, shows the importance of integration human and organisational factors in risk management practices (4.2.80).

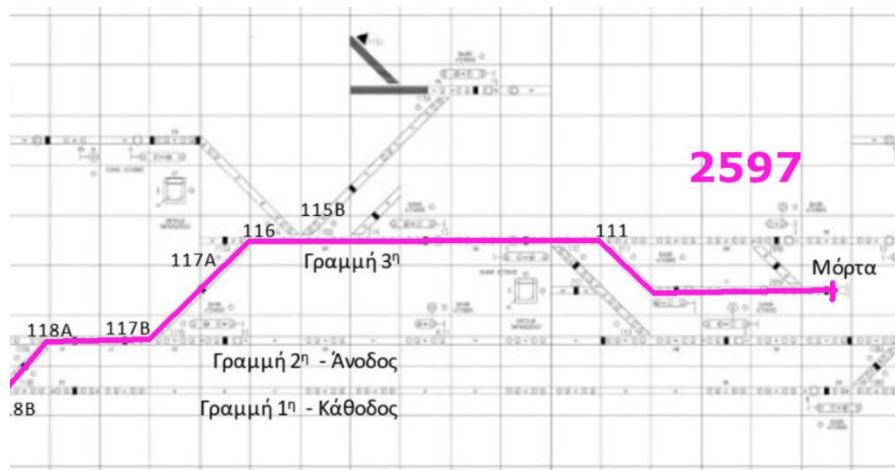
Figure 45. The route for the entry of train 2597.

- 222 Approximately around 22:35, after having received a call from the train driver of train 2597 that he was approaching the station, the station master of Larissa manually set the route with the intention for train 2597 to enter Larissa station from the north and be guided to the dead-end track between tracks 2 and 3.
- 223 This would require the setting of switches 118A/B, 117 A/B, 116, 115B and 111 to be turned in the adequate position (Figure 45). Note that this is also the action that directed switches 118 in the bypass position. Before that, these switches were turned in the straightforward position at 22:12 for the entry of train IC-63. From the recorded actions on the control panel, it can be seen that this was the last time before the departure of train IC-62 that the switches 118 were manipulated through automatic route setting.

When manually setting the route for the entry of train 2597, the station master of Larissa forgot to turn the switches 116 and 115B in the correct position. On other occasions these switches would have been in the right position after the entry and acceptance of train 2575 from Volos on track 3. Earlier in the evening, on the 28/02 this train 2575 was positioned on track 6 at 22:10 by the station master of the afternoon shift because track 3 was occupied with train 2594 that had been brought back to the station at 21:30 after traction problems arose on its way to Neoi Poroi (93).

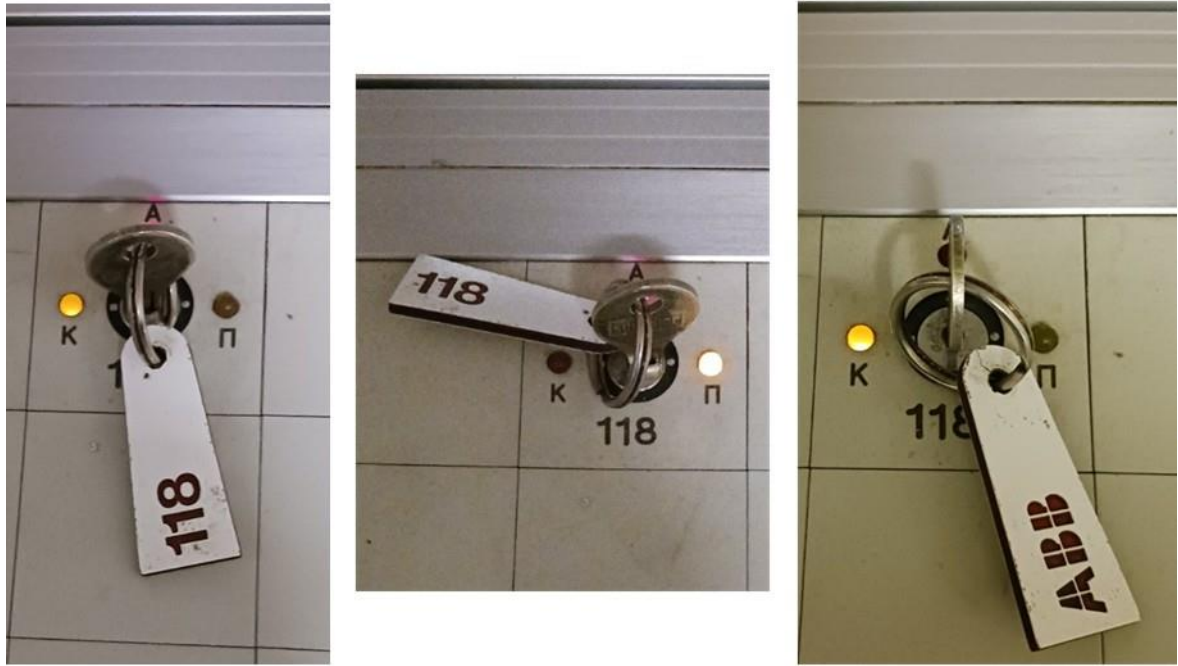
Figure 46. Detail of the three-position key for handling switches 118 on the Larissa Control Panel.

- 236 On the upper part of the control panel, there are three-position keys that are numbered according to the electrically driven switch they handle. These keys are used for the independent, manual control of any electrically driven switch. Turning the key from the central position by 90 degrees counterclockwise will command the switches to move to the "main" position (indication "K"). Similarly, by turning the key 90 degrees with the clock, the switches are commanded to move to the "bypass" (indicator "П") position. When there is a correspondence between the physical position of the switches and their control key, the yellow light diode for the indicated position of the switches is lit steadily. Above the key of each switch, there is also a red light diode, in the central position marked "A". This is the position the key should be put in to allow for "automatically setting" the routes. (Figure 46).

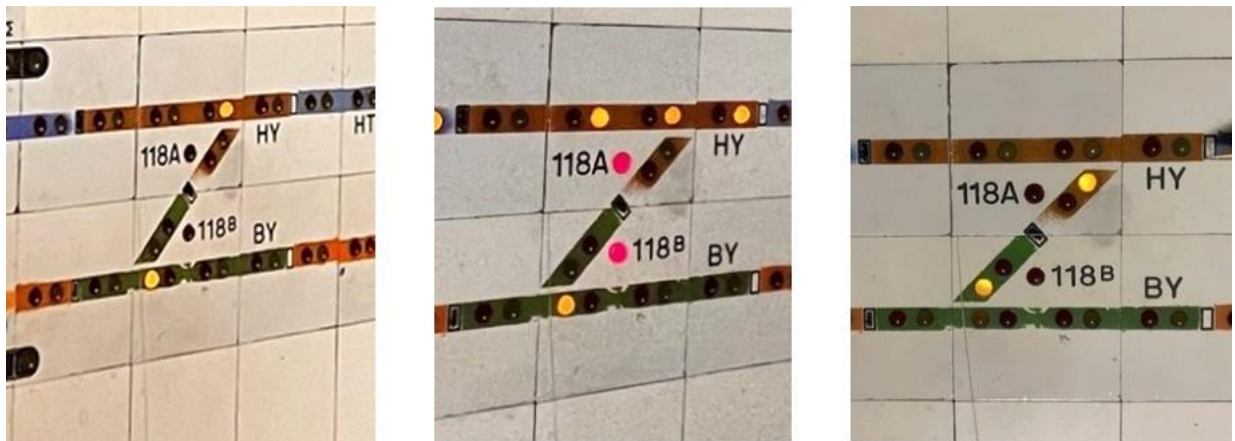
Figure 47. Detail of the switches 118 on the Larissa Control Panel (main-moving-bypass).

237 Switches are indicated on the Control Panel by the intersection of the lines showing the railway lines. Each switch is marked with a number and a letter if two switches have the same number. There are two yellow lights that indicate the position of the switch position in "main" or "bypass"(Figure 47). By setting the route, the lights in the area of the switches light up, as a combination of the light at the entrance of the switch and either the "main" or "bypass" path.

- 243 The indications on the position of switched 118 are small indications, on two distinct positions, on a larger Control Panel (the information of the Figure 47 among the ones from the whole Figure 37).

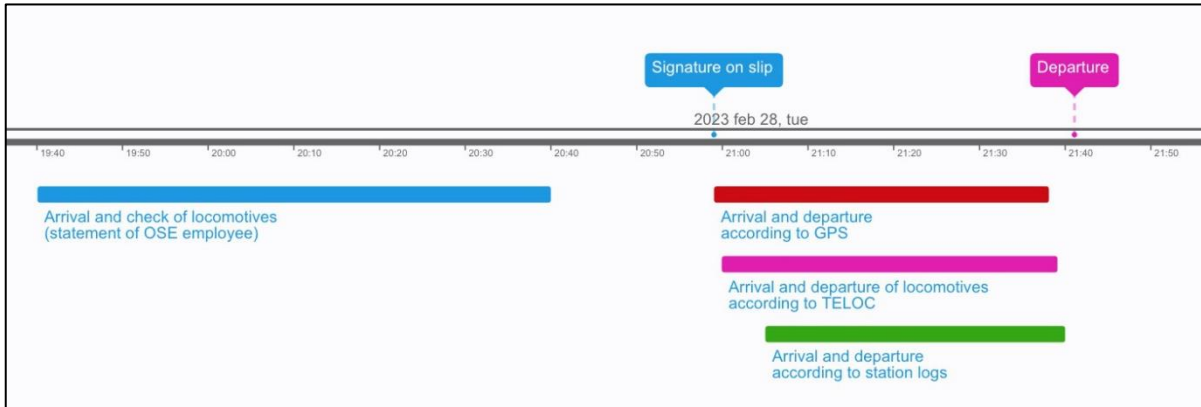
Figure 51. Timeline of the movement of the freight train 63503

284 The same timeline of events is supported by GPS data of the movement of the locomotives as provided by Hellenic Train. A similar timeline is supported also by the logbook of the station master at Thessaloniki Freight Station (locomotives arrive at 21:05, test finished by 21:35 and train leaving at 21:40).

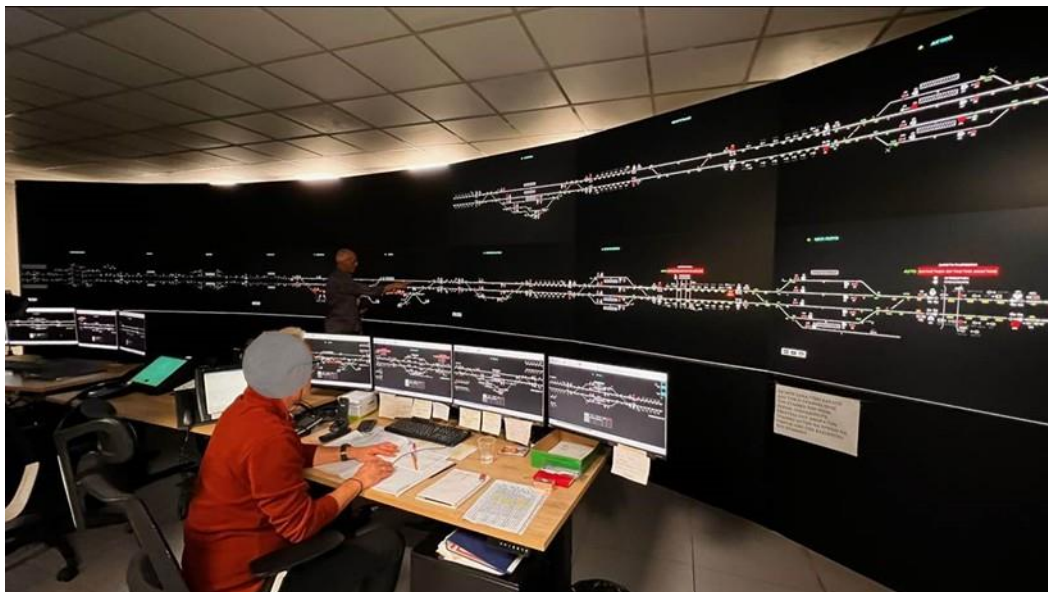
Figure 52. Digitalised traffic control room in Larissa station, with experienced staff, in 2025.

315 Another level of performance monitoring is also possible through the digitalised traffic control rooms (note that such a control room was not in place at the Tempi accident occurred), and this concerns the supervision of traffic in tunnels, and also, as in the example below, traffic management itself. As was observed during on-site visits (Figure 52), on several occasions during the investigation, it is clear that decision made via the control panel in Larissa station a few dozen meters further on (just as it could also be fifty or hundred kilometers) can easily be observed and supervised. However, it is currently not used in that way, and it is not clear if there is any intention to do so in the future. It was observed that there has been an effort to put into operation these traffic control rooms wherever infrastructure (signalling) is available. Their use, however, is still limited by lack of the maintenance of the switches. As a result, still large parts of the Athens-Thessaloniki route are not monitored remotely.

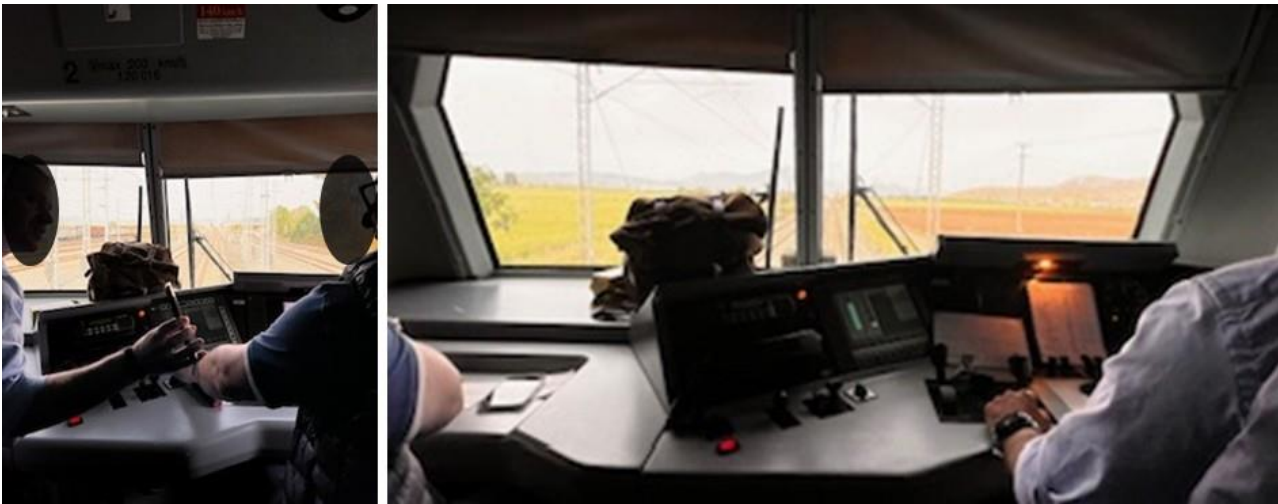
Figure 53. Photos of the train drivers crew, positions and alternance.

349 Another important part of the competence management system is related to non-technical skills, behaviours and attitudes. As previously reported (264, 265), in a context where two train drivers (and sometimes even more) are sharing the driving responsibilities in an alternate way (Figure 53), it is expected they benefit from a crew resources management training, developing their non-technical key competencies (ex. management of stress, of time, of anger, error detection and recovery, etc.). This would also include the capabilities, the willingness, and openness to solve and report any issue related to safety in a context of diverse interpersonal relationships (especially with issues related to obedience, power, and respect issues). This type of peer-review and/or crew resources management is useful when well framed and embedded in an open culture, and in the training of non-technical skills, and eventually contributing to the overall performance and continuous improvement. We could however not identify any structured approach and or guiding directions that would support this.

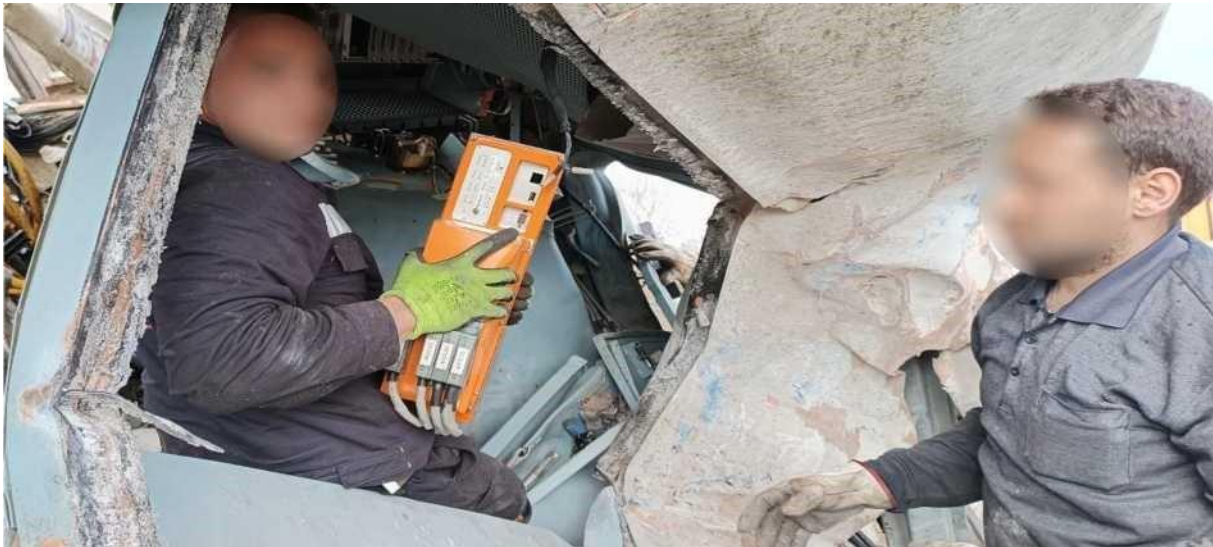
Figure 54. On board TELOC data recorder, train 63503, locomotive 120-022, retrieved by judicial experts on the 05.03.2023.

416 At the moment of the first impact, as registered by the on board TELOC data recorder that was retrieved from the accident site, the speed of train 63503 was 89.91 km/h. This is within the speed limit of 100 km/h for freight trains at this location (4.2.4). Since the train drivers of train 63503 could not possibly have identified the impending danger of the passenger train coming out of the tunnel earlier, emergency braking was activated only one second before the actual impact.

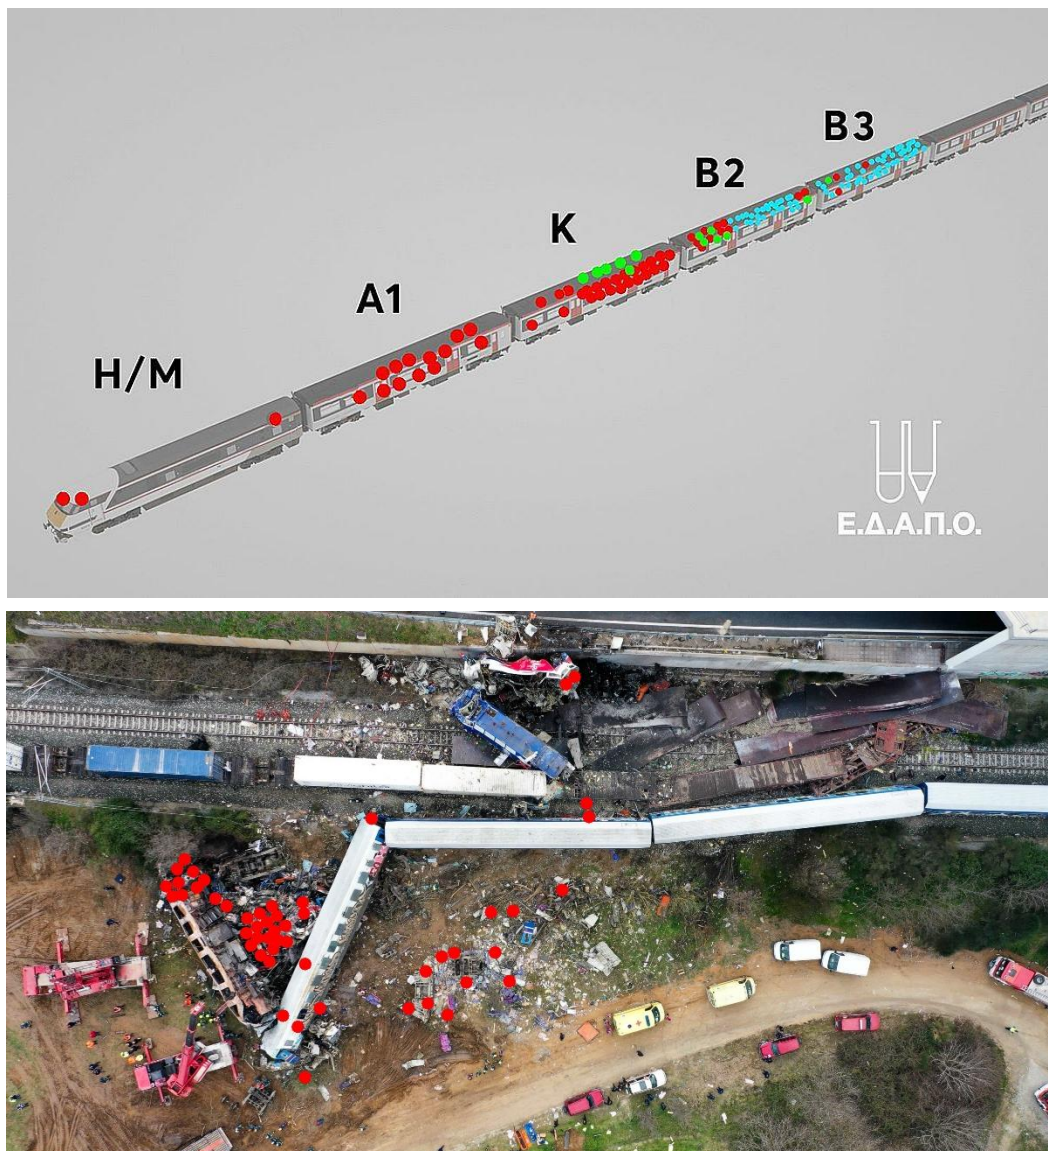
Figure 55. Initial and final estimated positions of fatalities, visualised on the scheme of the impacted part of the IC-62, and on-site.

- 423 The B3 coach of the passenger train was not subjected to heavy deceleration forces and was totally survivable, if not for secondary impacts from the B2 coach hitting its roof and a section of the locomotive hitting against the side of the B3 coach. There were 2 casualties that both suffered severe head and spinal trauma due to impact by heavy debris entering through the side windows. Both casualties were killed instantly without any chance of survival, given the unlucky position they happened to be at (other passengers sitting next to them were practically unharmed). And 5 injured victims were ejected during the crash or jumped from a height to exit the carriage.

- 445 Of the total length of the passenger train IC-62, the only parts that were totally consumed by the fire were the rear part of the Restaurant Car (letter K on the drawing, Figure 55, page 91) and the B2 passenger coach.

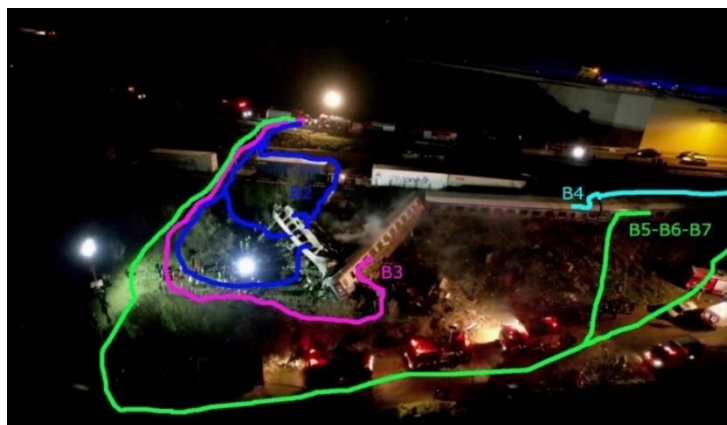
Figure 56. Self-evacuation paths of passengers before emergency services arrived at the scene.

- 427 Passengers from coaches B4 to B7 managed to operate the emergency handles of the doors and open the doors to self-evacuate successfully. On the B3 coach, access to the front doors was limited due to parts of the roof collapsing and blocking the narrow passage to the door. Passengers chose to break a window on the left side and climb down from there in order to self-evacuate. The Fire Service used the same window in order to enter and evacuate 3 casualties and 3 injured passengers who were trapped and needed mechanical tools to release them.

- 428 At least two passengers sustained serious injuries (bone fractures and dislocations) during evacuation: 1 female passenger jumped from the top row of windows of the B2 coach and was injured by falling on debris below (subsequent passengers jumping from the same window avoided this by throwing their luggage to land on top of softer surface) and 1 male passenger who was the first to jump from the B3 coach front left window, sustained serious injuries by falling on debris below (subsequent passengers evacuating from the same window took care to climb down carefully in order to avoid injury). An unknown number of passengers were reportedly lightly injured during evacuation, mostly in a similar way.

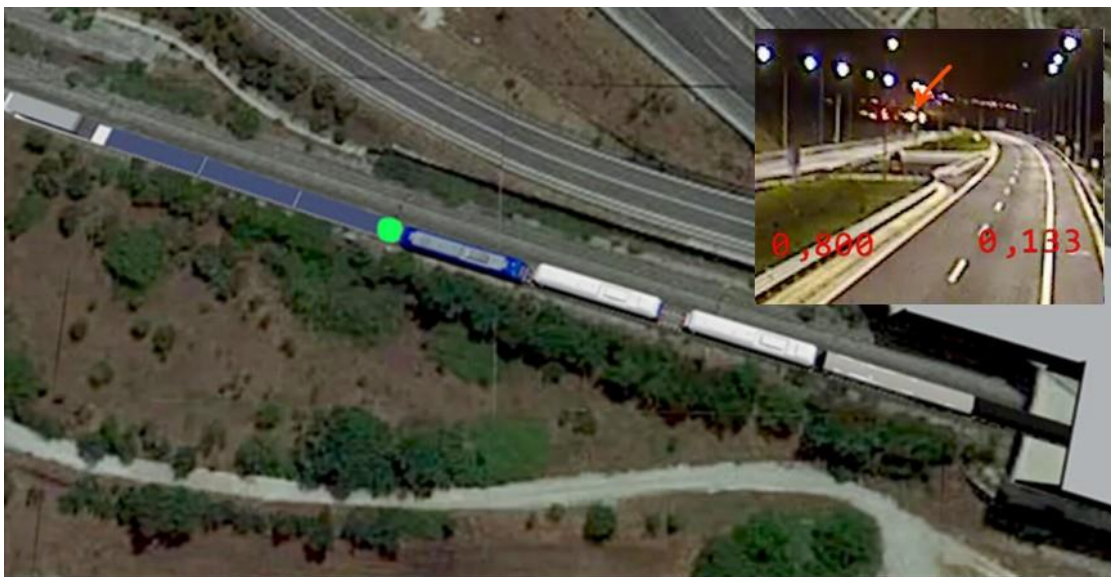
Figure 58. Estimated point of initial ignition.

- 456 The deflagration is ignited approximately 0.3 seconds after observing the electric arc, and it starts at ground level (note the hemispherical shape) with the huge amount of sparks from the emergency brakes locking the wheels of both trains (consistent with victims' testimonies) being the most probable source of ignition.

- 457 A comparison between the viewing angles of the three available cameras with an effort (via triangulation coupled with kinematic analysis of the crash sequence) to locate the exact point of initial ignition shows a probable point of ignition in the area between the 2nd locomotive of the 63603 freight train and the first flatbed carriage of the same train (Figure 58).
