Rail Accident Report

Head-on collision between a passenger train and a freight train  
in Tempi, 28 February 2023

RL01-2025, 27 February 2025

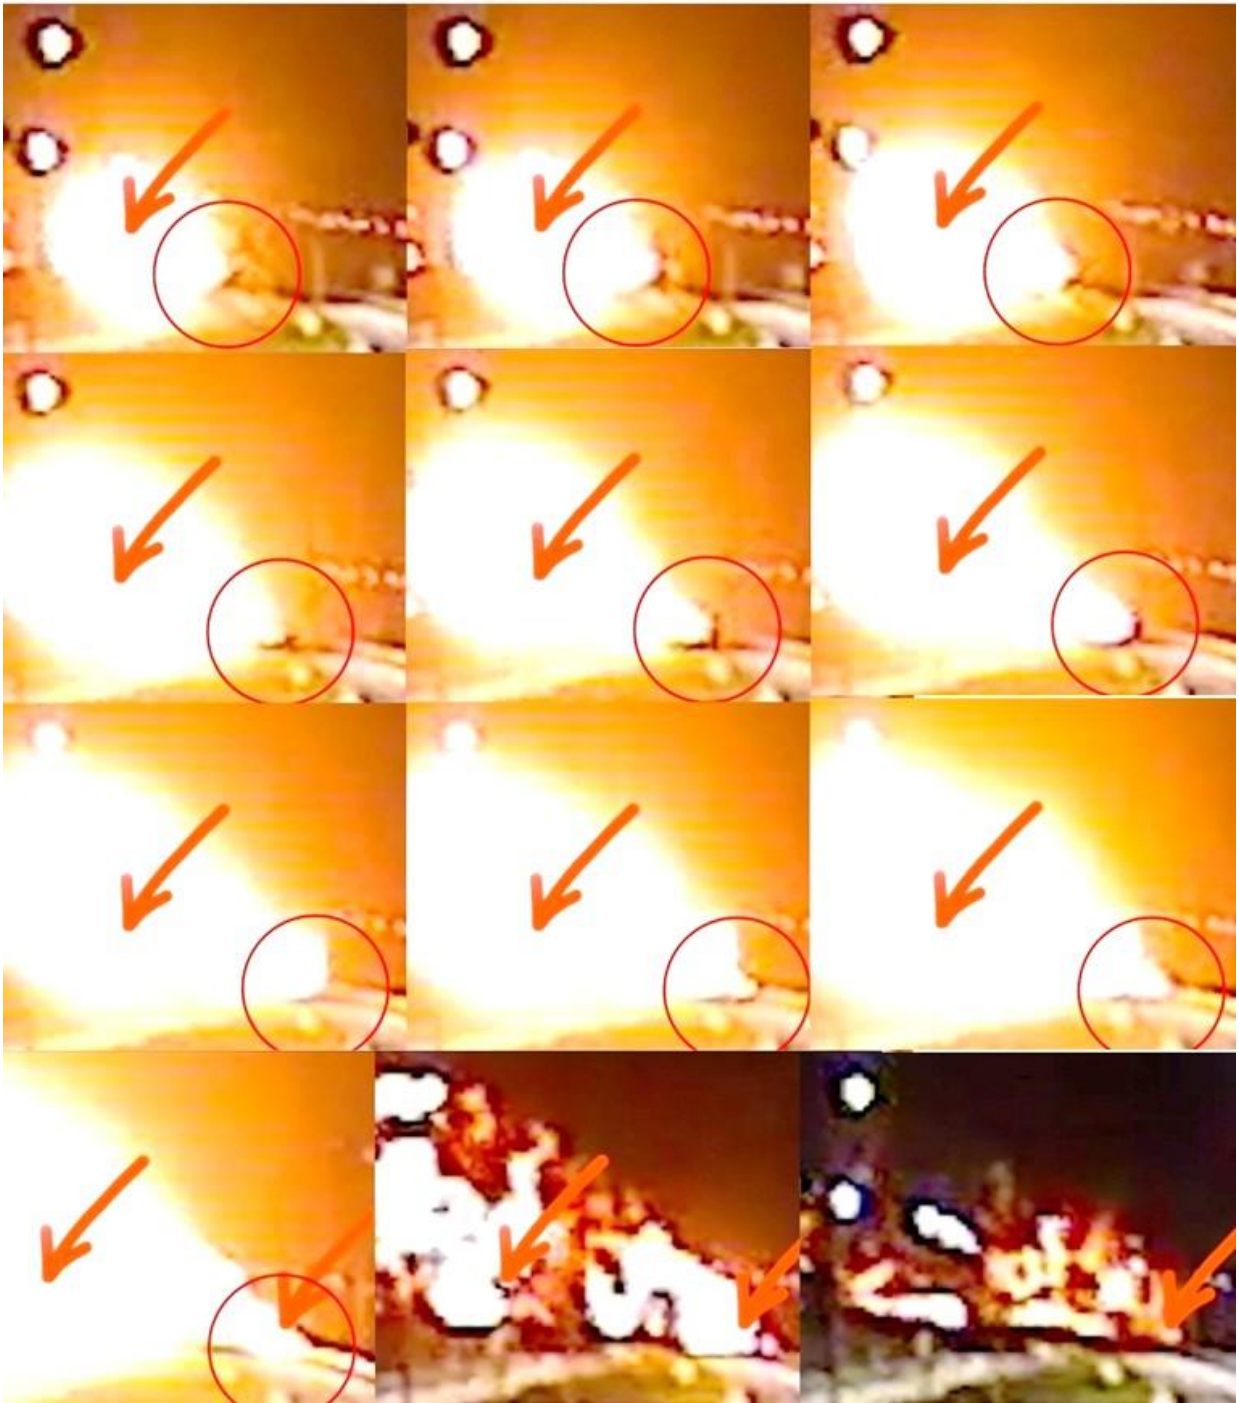
Figure 59. The sequence of the fire from the point of collision to the final stage.

- 458 The following sequence of images (frames from the Aegean Motorway video) starts at 2 seconds after the initial deflagration that started at the place indicated by the red arrow. As can be observed by these video frames, a dark irregular shape is moving in a northbound direction for a duration of approximately 4 seconds, during which time strong flames can be observed coming out. The distance covered was approximately 40 meters so this gives a mean speed of 10m/sec or 36kph for the carriage until it comes to a stop.

- 461 The above frames from the Aegean Motorway video (Figure 59) do not allow to identify the dark irregular shape. To be able to identify this part of the passenger train that was making the fireball move to the north, evidence from the video that has recorded the event from the southern side ("Maliakos-Kleidi" camera), and other available videos collected by passengers a few minutes after the crash was correlated.

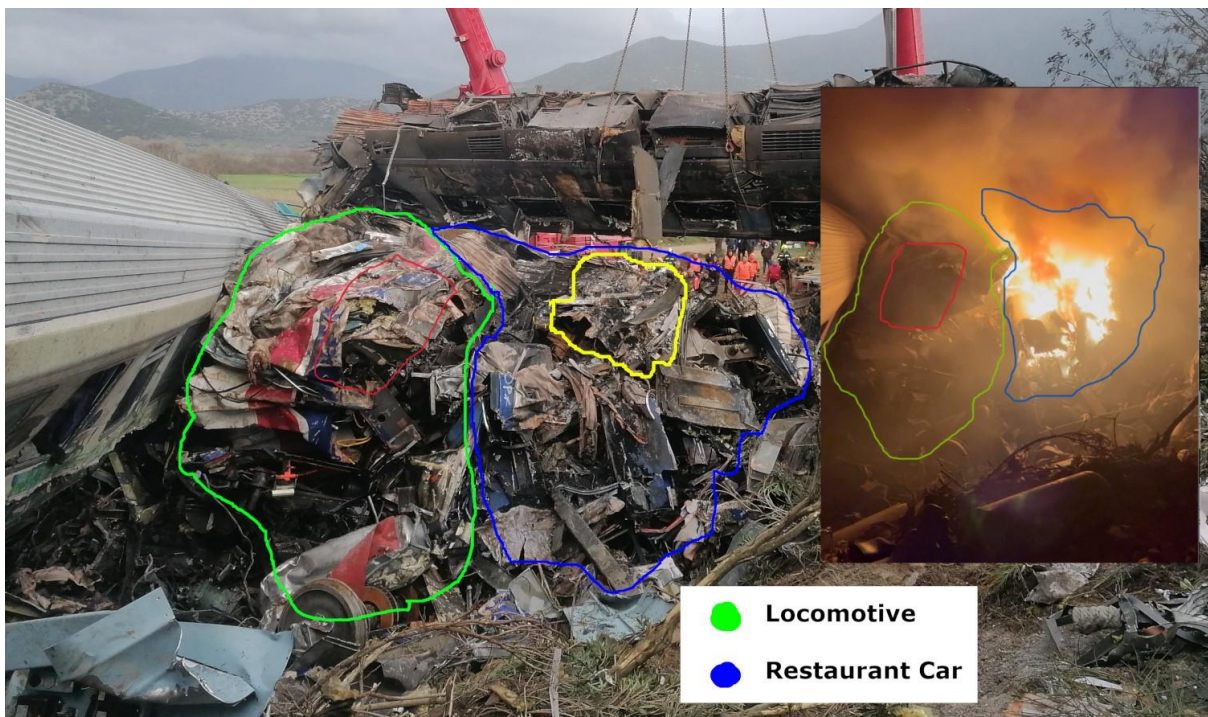
- 462 The passenger videos show a very strong but very concentrated fire burning fiercely from the bottom of the Restaurant Car (color yellow added) while the remains of the passenger train locomotive (including the transformer filled with silicone oil) can be observed at a very close distance but clearly not on fire. This observation can be verified by the examination of the remains of the trains on the next day (Figure 60, Figure 61), where it is clear that the locomotive (color green added) is mechanically destroyed and, like the transformer (color red added), only has burn marks on one side, while the Restaurant Car (color blue added) is totally consumed by the fire.

Figure 60. Restaurant burning next to the passenger train locomotive, with the position of the transformer in red.

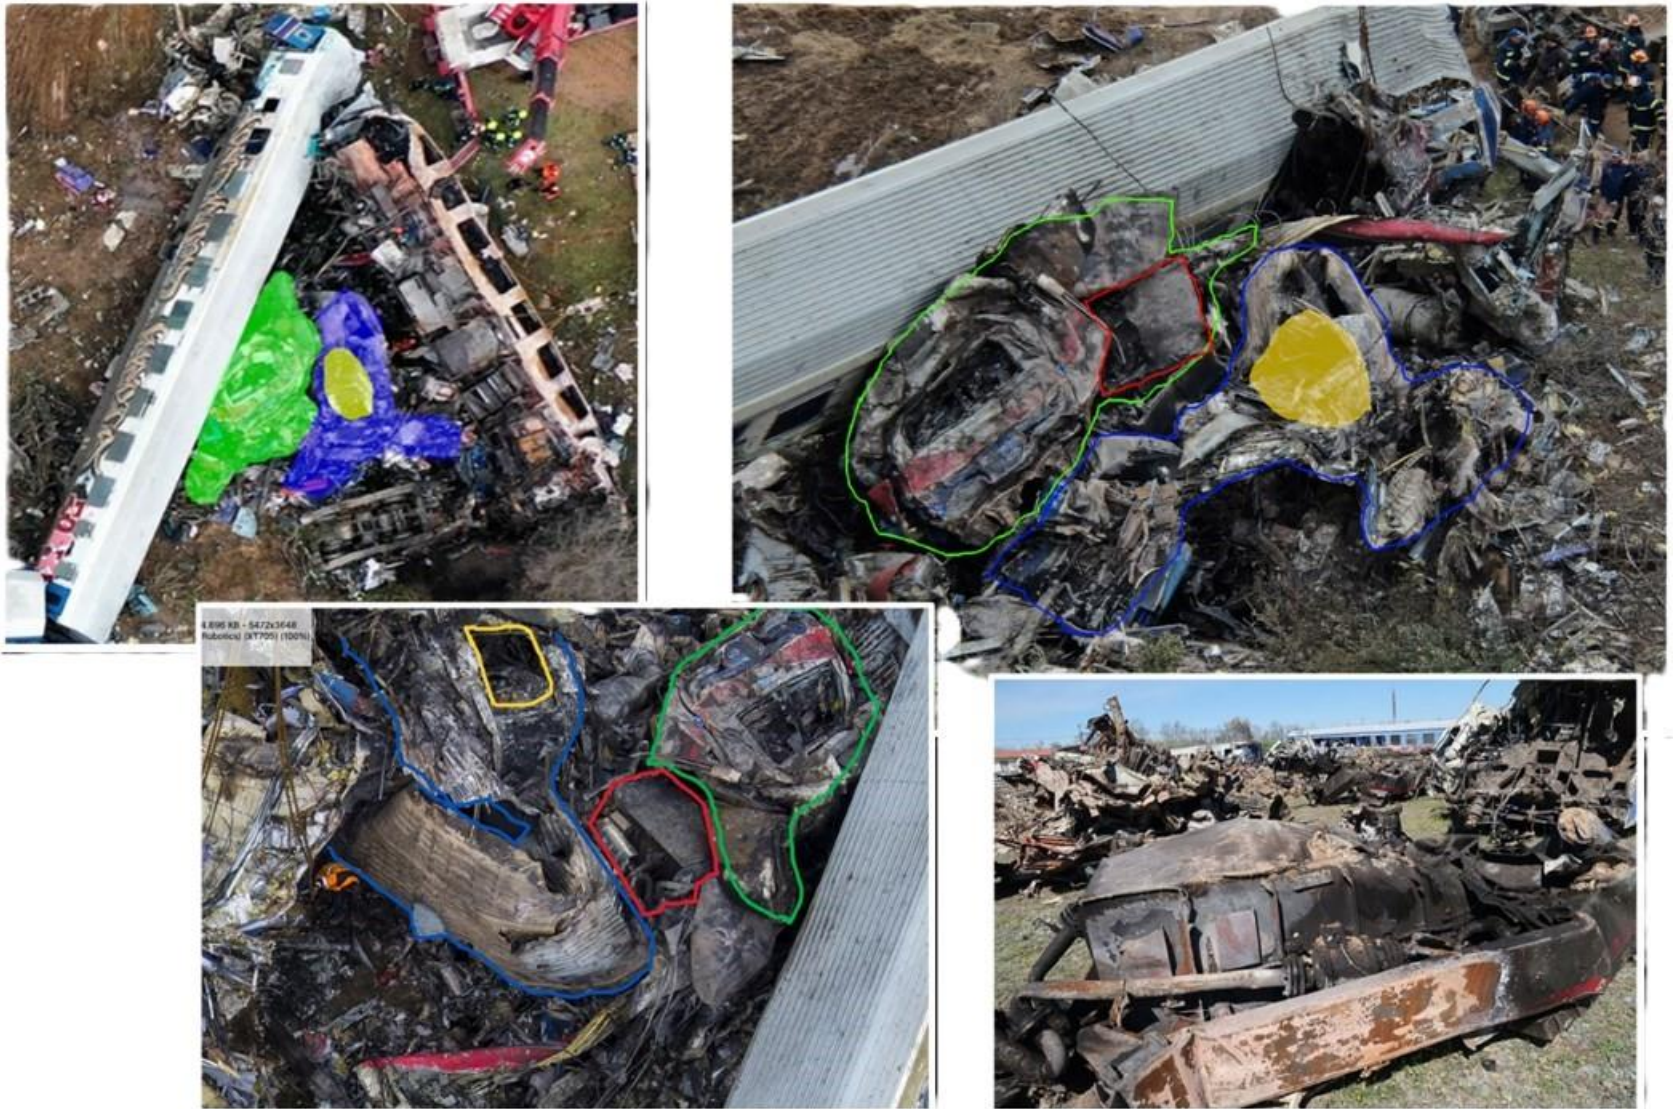
Figure 61. Further images of the location of the Restaurant Car, Passenger Locomotive and its transformer.

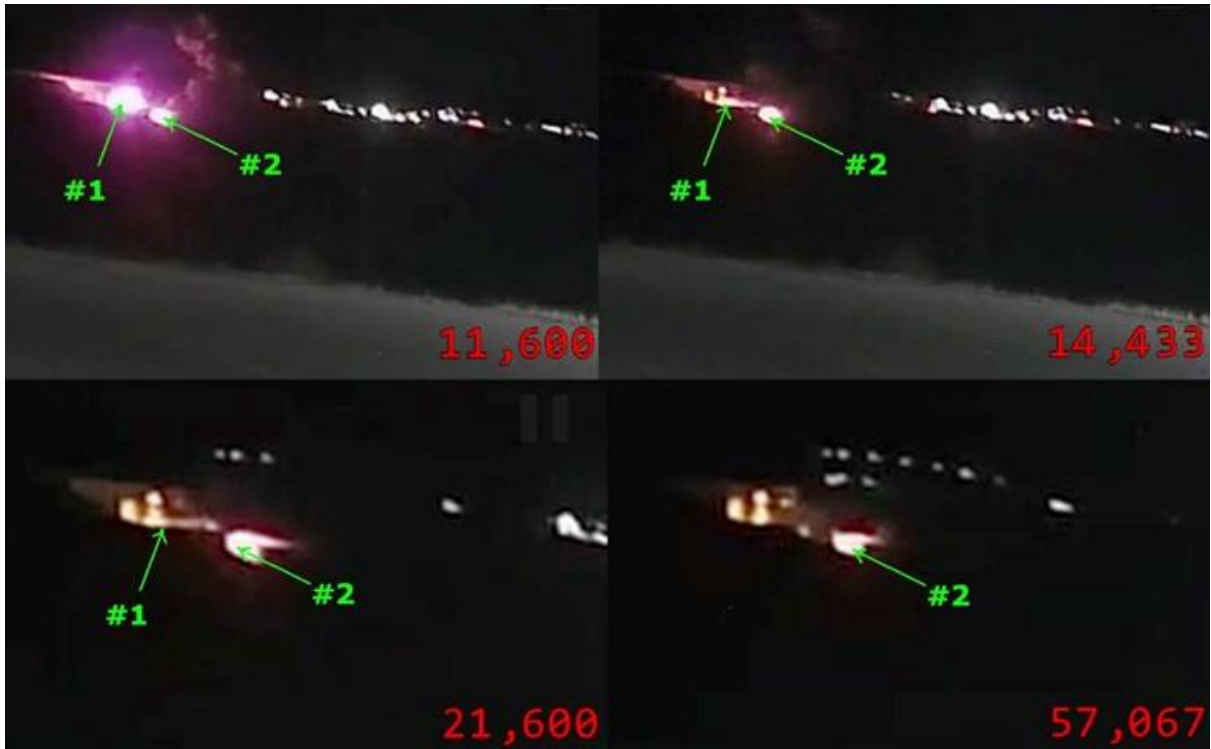
463 By following this fire backwards in time, it is most likely that the fire that consumed the Restaurant Car is the same fire that has been recorded 4 minutes after the crash, burning from the bottom of the (crashed and bent in an S-shape) Restaurant Car (color yellow added). This is also the same fire that is observed from the "Maliakos-Kleidi" camera (Fig. Y), as an uninterrupted continuous movement from the fire plume (stage 2) to pool fire #2 (stage 3).

Figure 62. Fire plume moving into pool fire #2, as observed by the "Maliakos-Kleidi" camera.

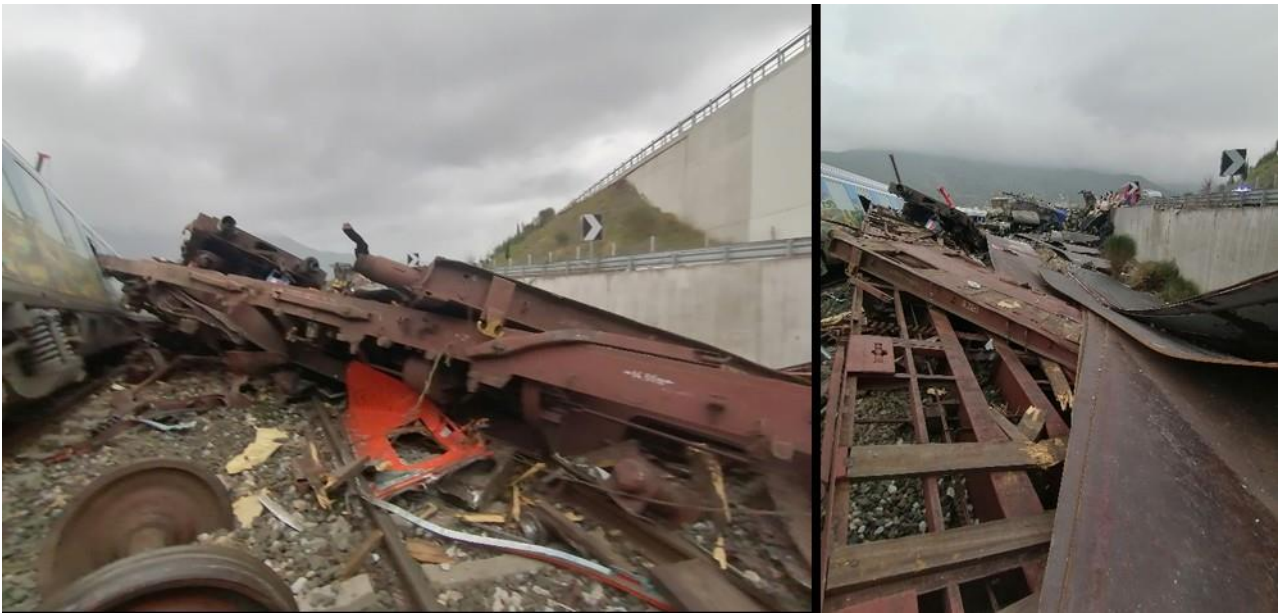
Figure 82. Platforms as found on the accident site.

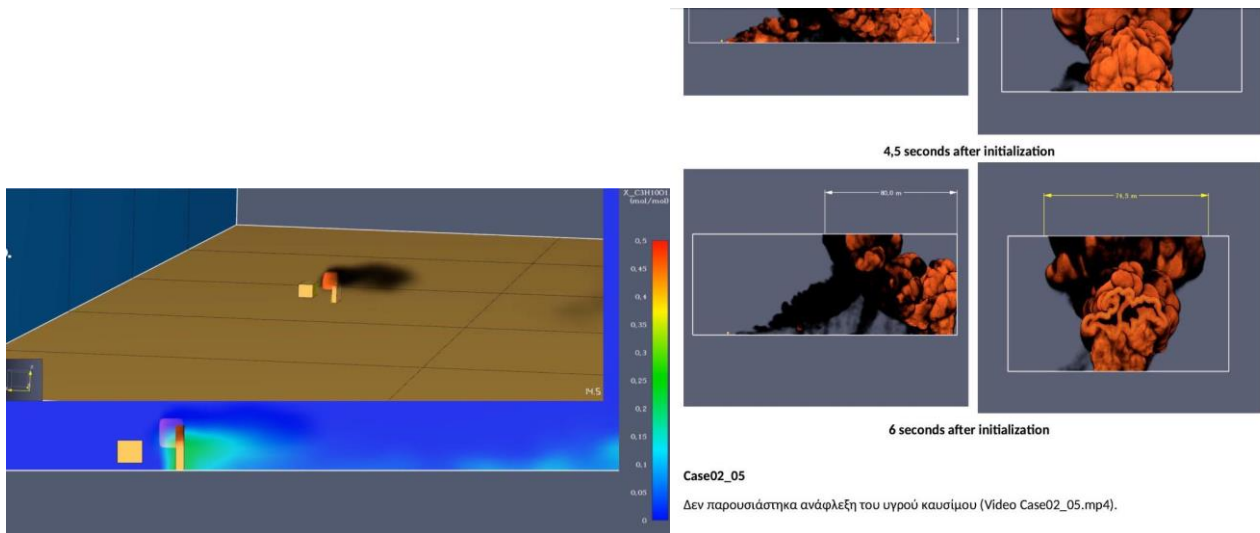
The results of these tests rule out the possibility of PDMS silicone oils creating such a big fireball and pool fire, as the only possible result is a small localized ignition that will not propagate through the rest of the material, even if the total quantity of silicone oil is unrealistically atomized and dispersed all over the area.
